Annual Inspection

Barby & Onley Parish Council

Barby Play Area

Daventry Road, Barby, CV23 8TT

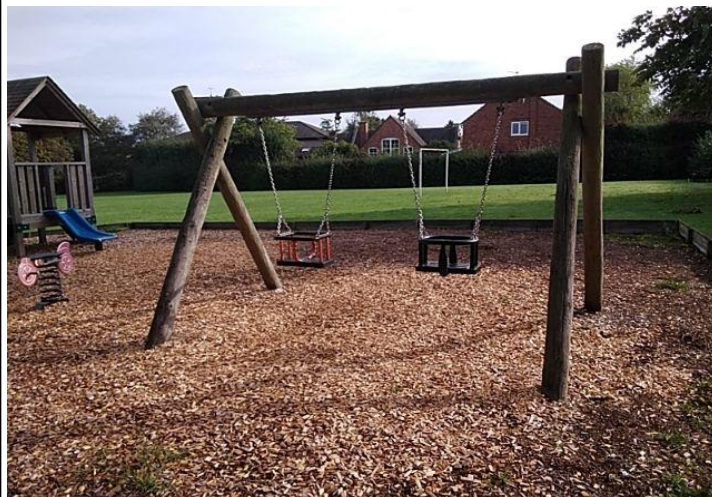
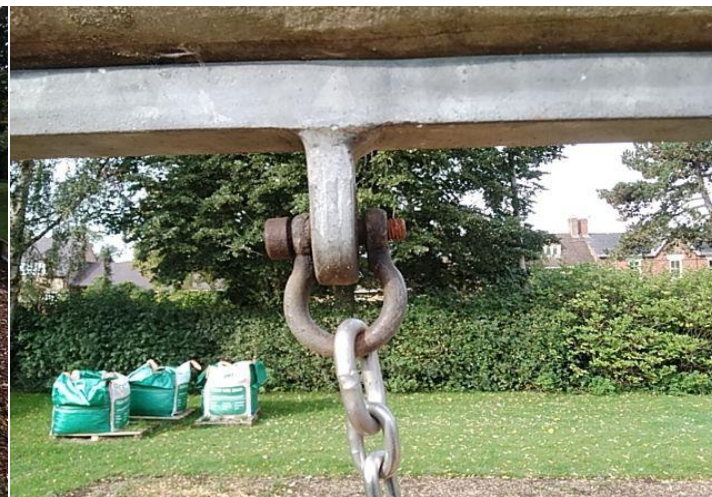
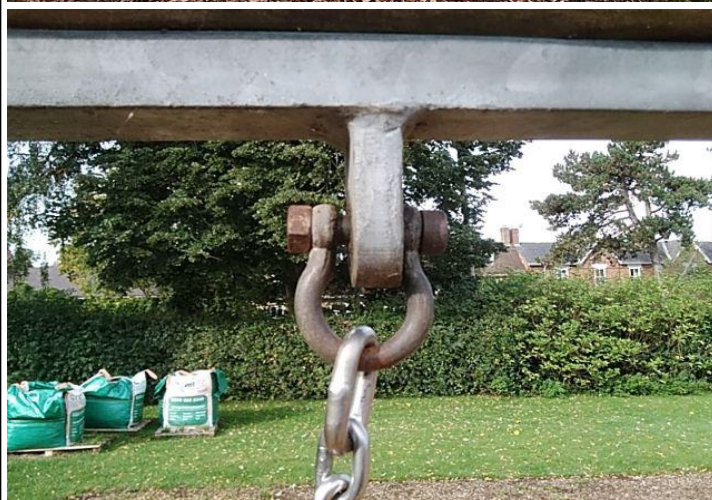
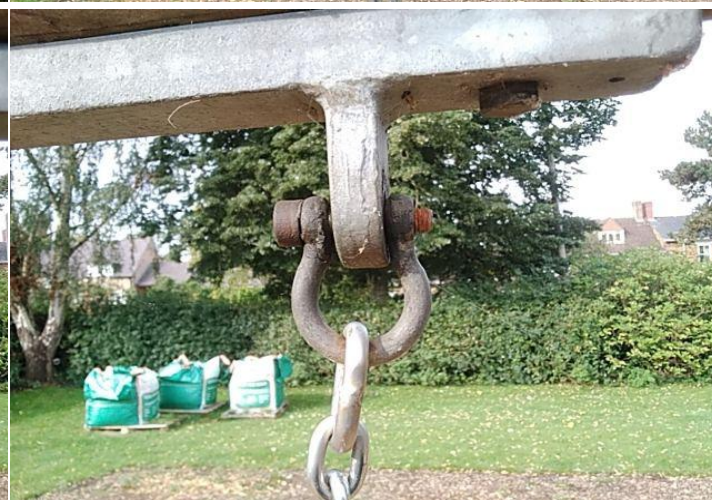
Finding: 2 shackle nuts are missing

Action: Replace all missing fixings

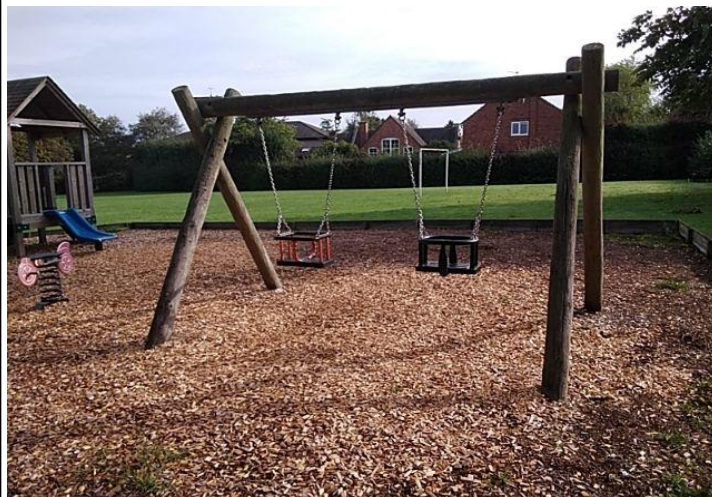
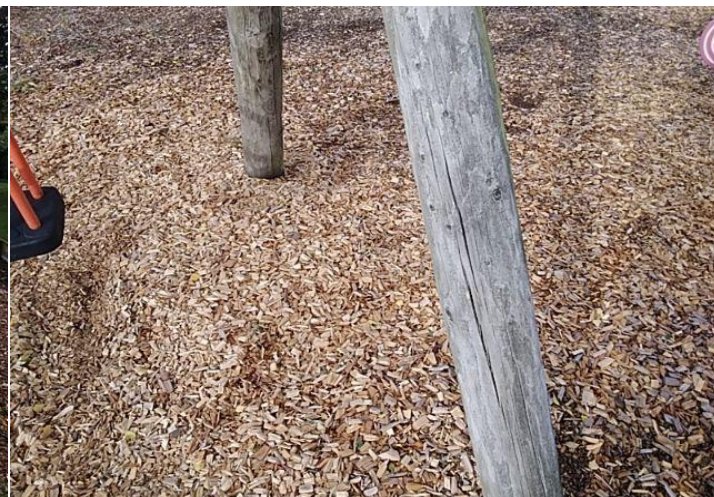
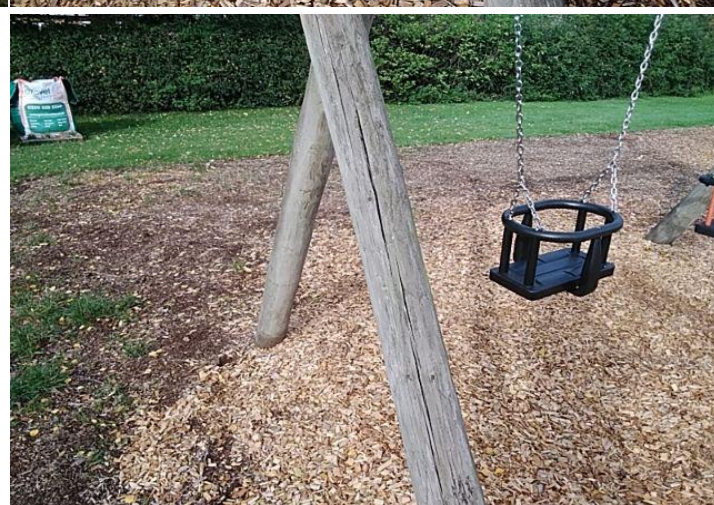
Finding: The timber has a number of splits/shakes or air cracks and this may affect the stability or allow water ingress which will accelerate the rotting process. The swing frame is in generally poor condition

Action: Monitor to ensure the splits do not cross through fixing points of the structure and/or cause any instability. Consider replacing the swing frame in the longer term

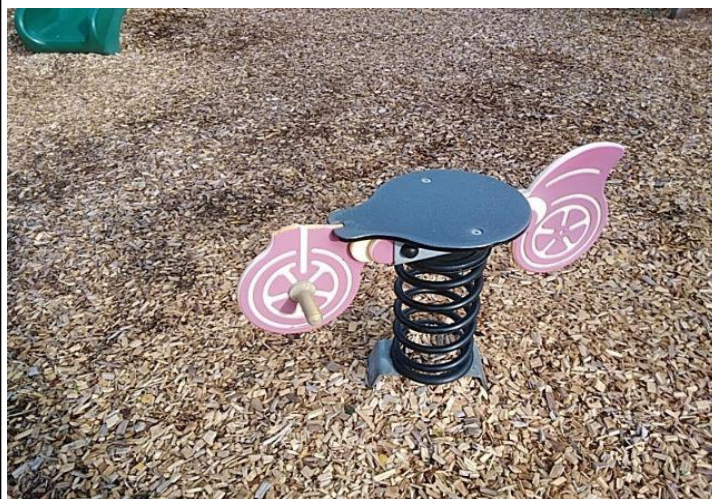
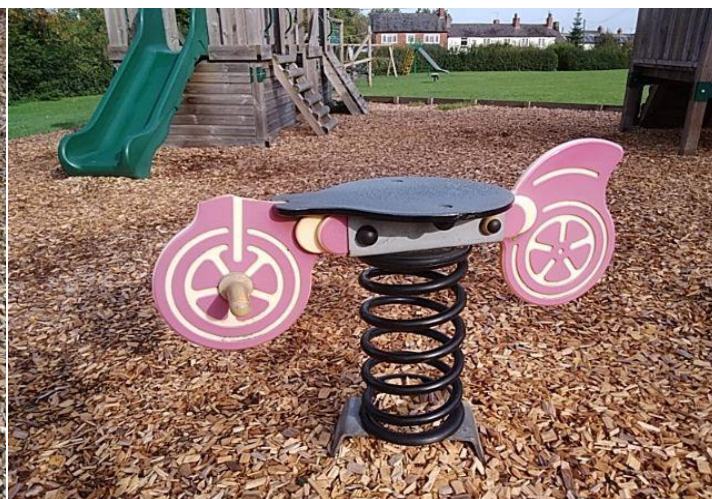
Finding: The front section is broken. There is nothing for children to hold onto when using the item

Action: Replace the damaged parts

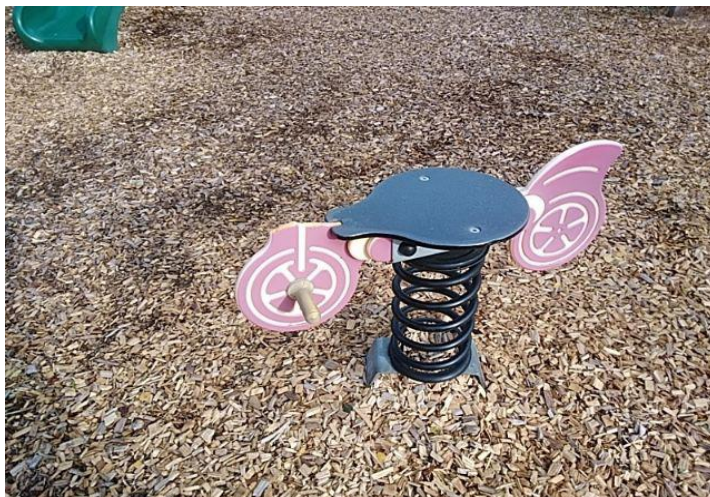
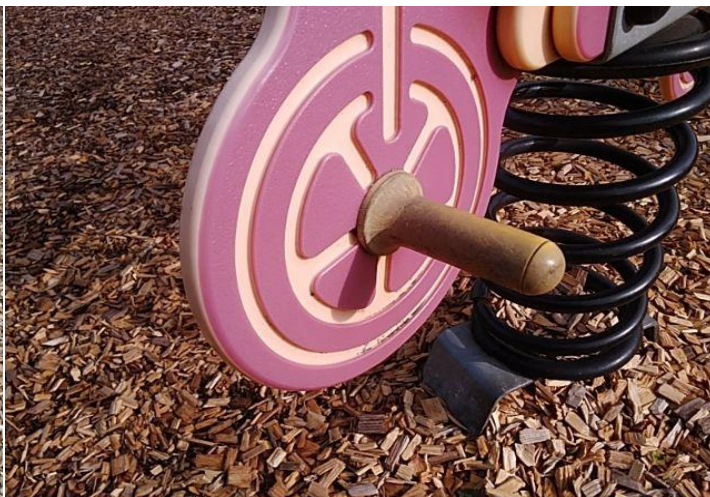
Finding: The end of handgrips and/or footrests have a cross section of less than 15cm² and fail to meet the requirements of BS EN 1176 Part 6
Action: Monitor - No remedial work recommended

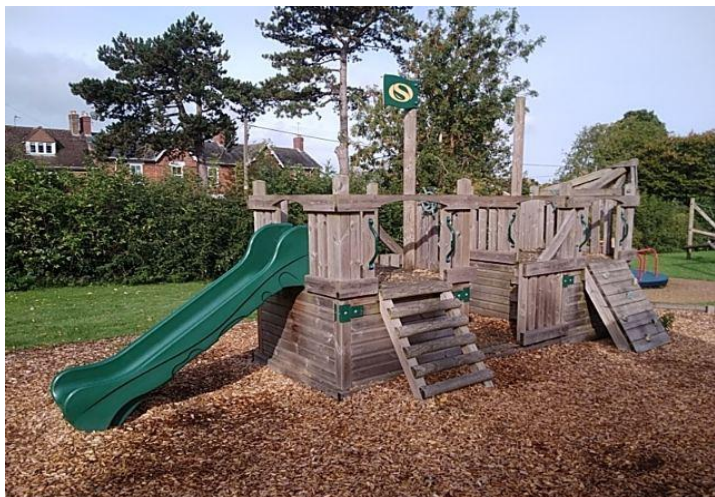
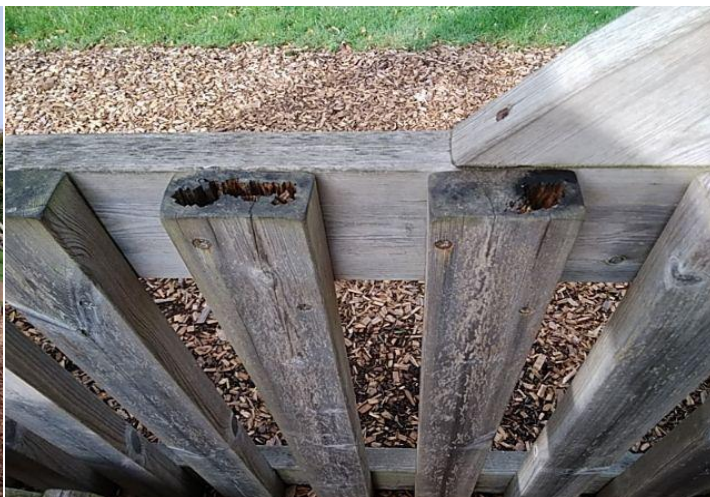
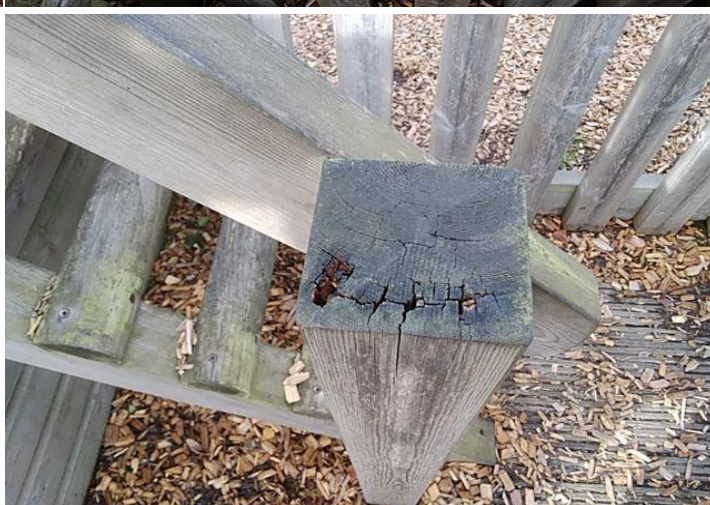
Finding: There is some evidence of rot in the timber

Action: Monitor for any further deterioration and replace as required

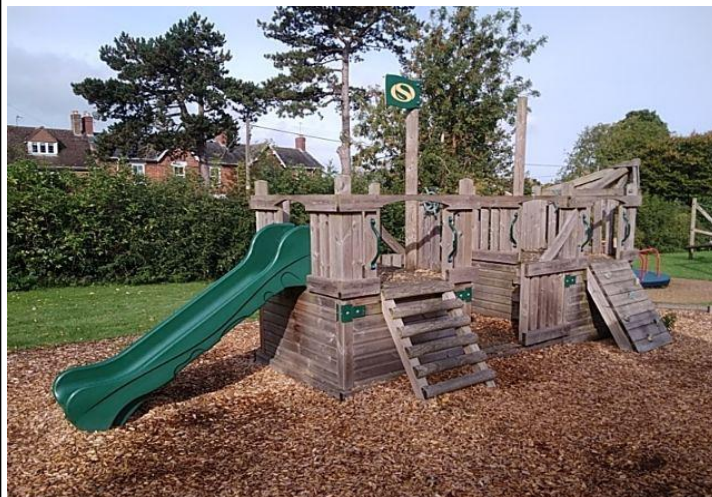
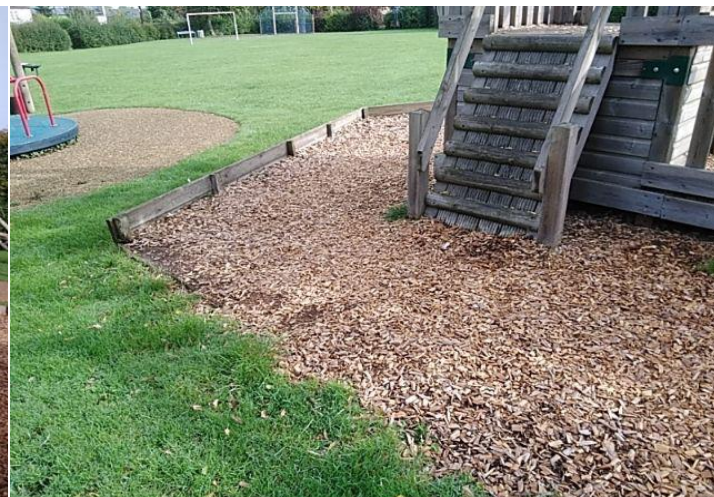
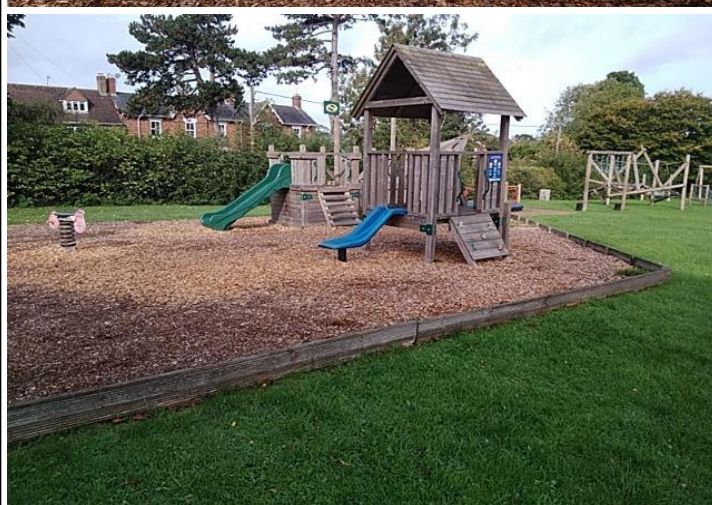
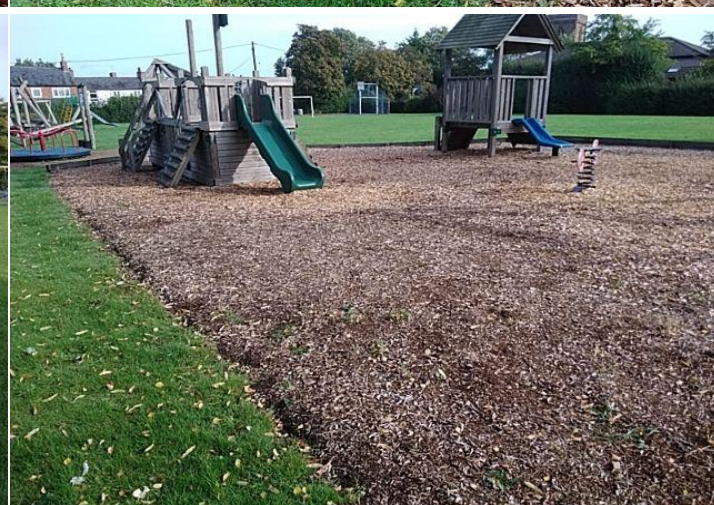
Finding: Some timber edging is missing

Action: Monitor

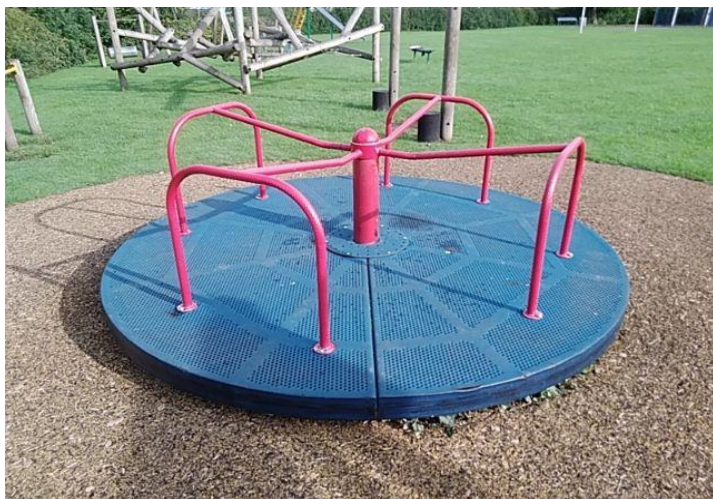
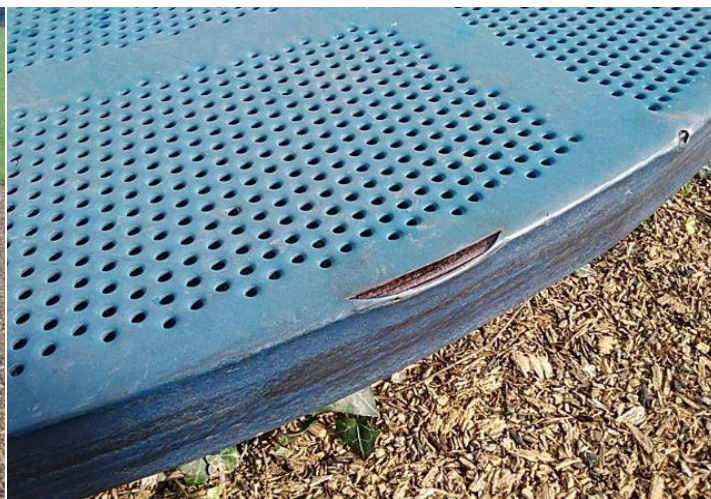
Finding: The item has been damaged **Action:** Monitor for any further deterioration and replace as required

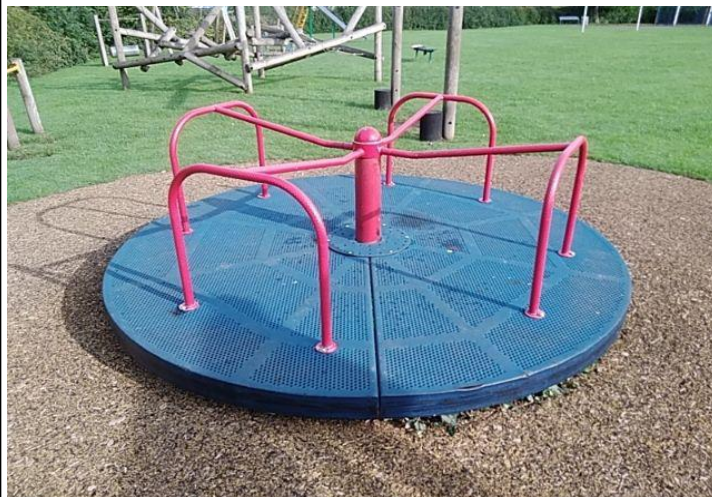
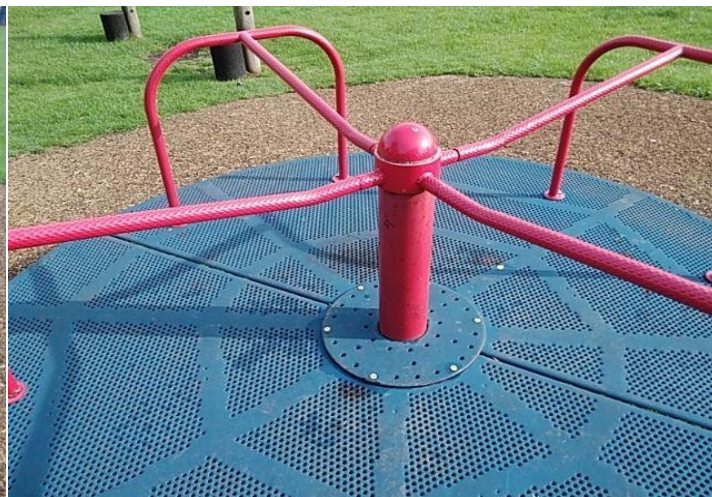
Finding: The item is slightly loose in its foundations or the bearings may be worn

Action: Monitor for any further deterioration and repair as required

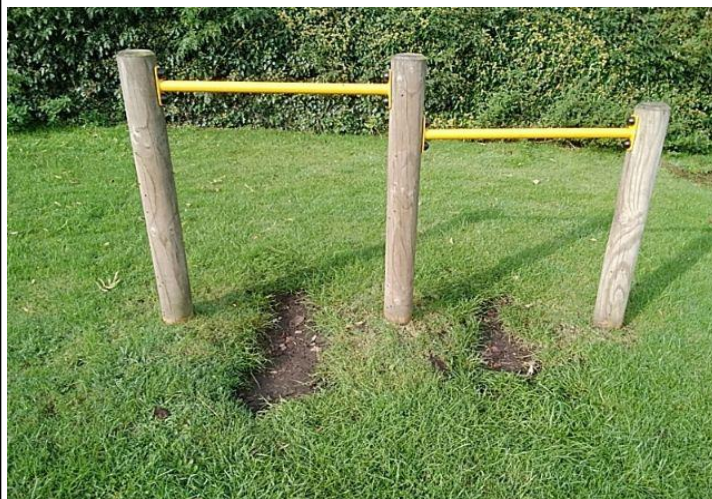
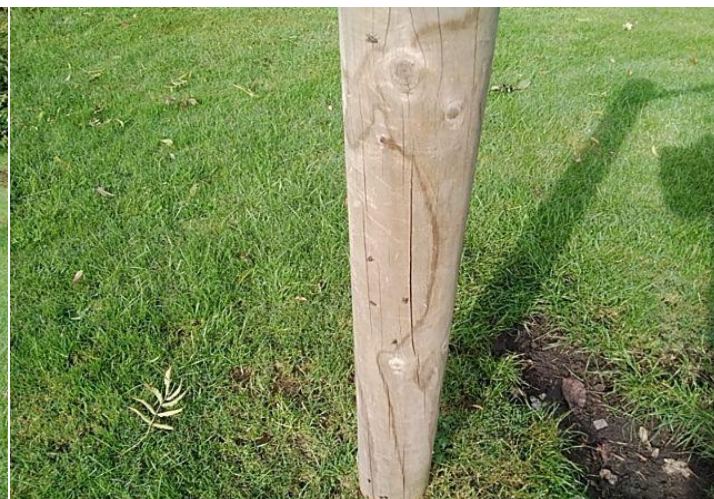
Finding: The timber has a number of splits/shakes or air cracks and this may affect the stability or allow water ingress which will accelerate the rotting process
Action: Monitor to ensure the splits do not cross through fixing points of the structure and/or cause any instability

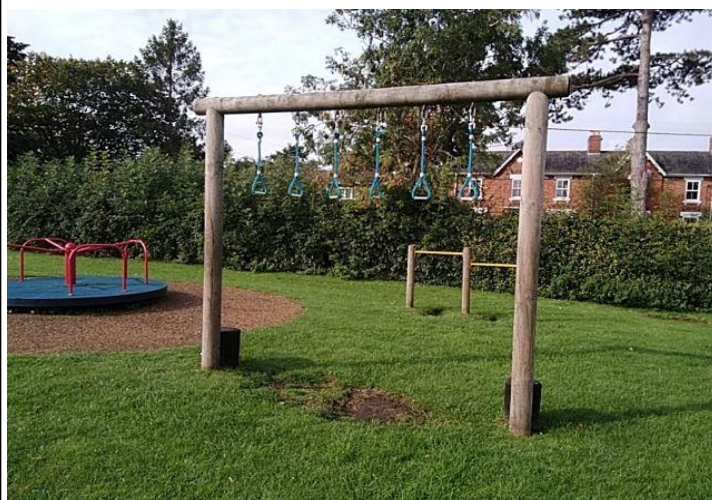
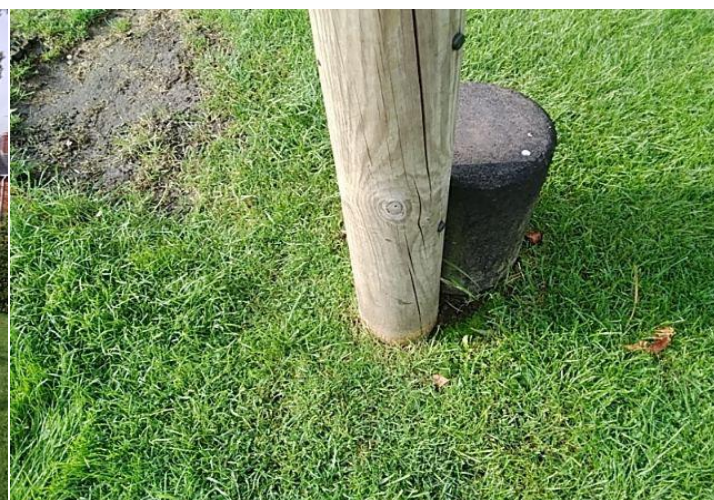
Finding: The item is slightly loose in its foundations
Action: Monitor for any further deterioration and repair as required

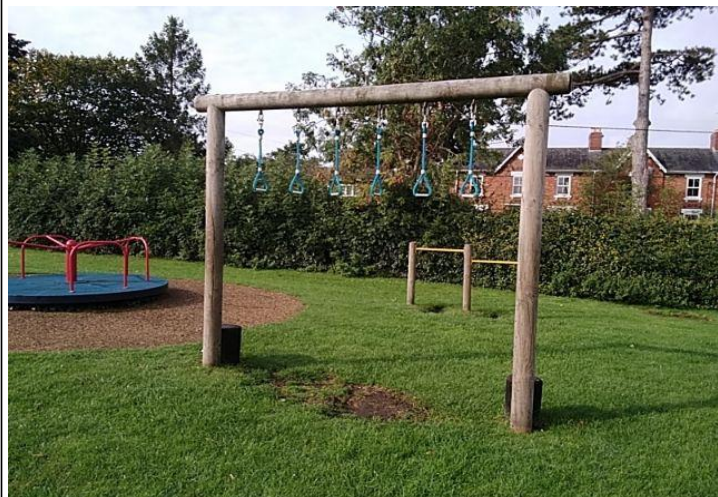
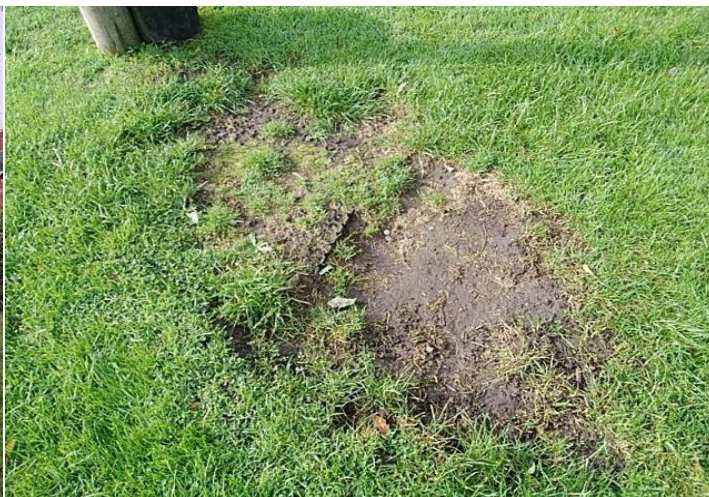
Finding: 1 grass mat is missing

Action: Replace the missing grass mat

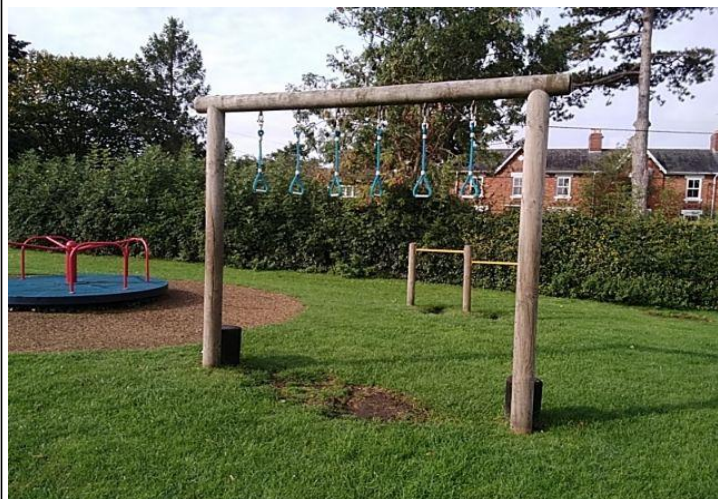
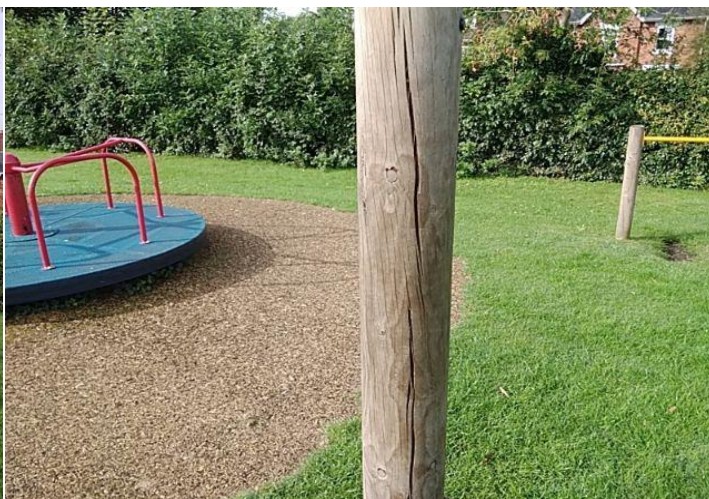
Finding: The timber has a number of splits/shakes or air cracks and this may affect the stability or allow water ingress which will accelerate the rotting process

Action: Monitor to ensure the splits do not cross through fixing points of the structure and/or cause any instability

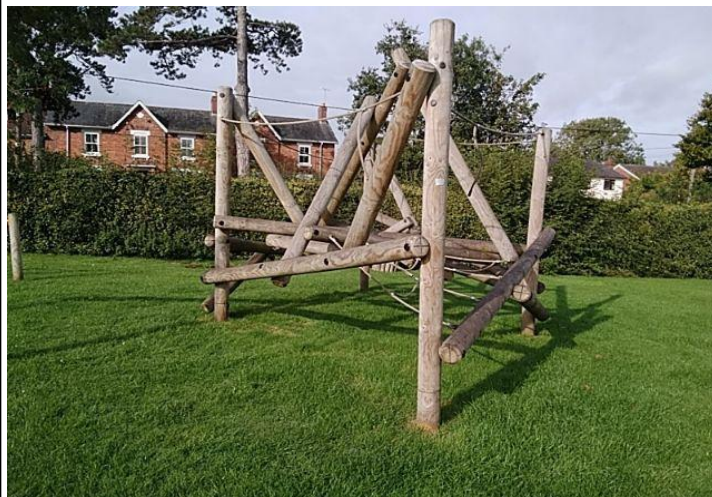
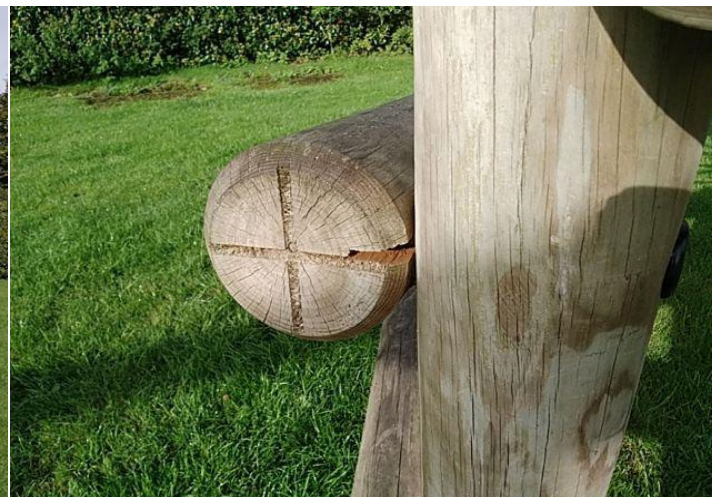
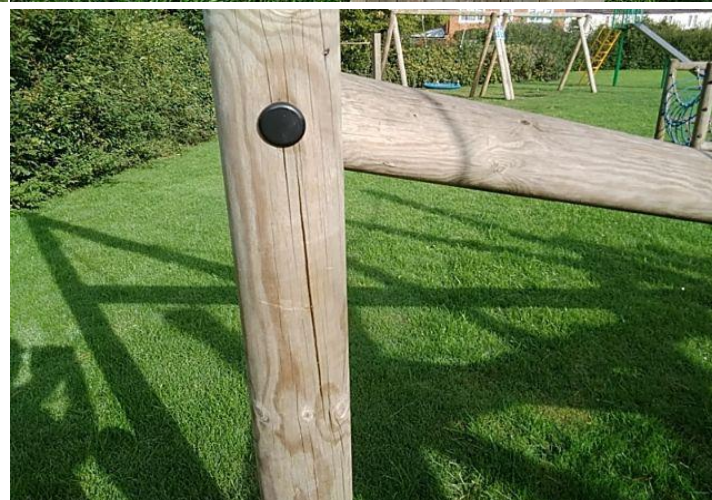
Finding: The timber has a number of splits/shakes or air cracks and this may affect the stability or allow water ingress which will accelerate the rotting process

Action: Monitor to ensure the splits do not cross through fixing points of the structure and/or cause any instability

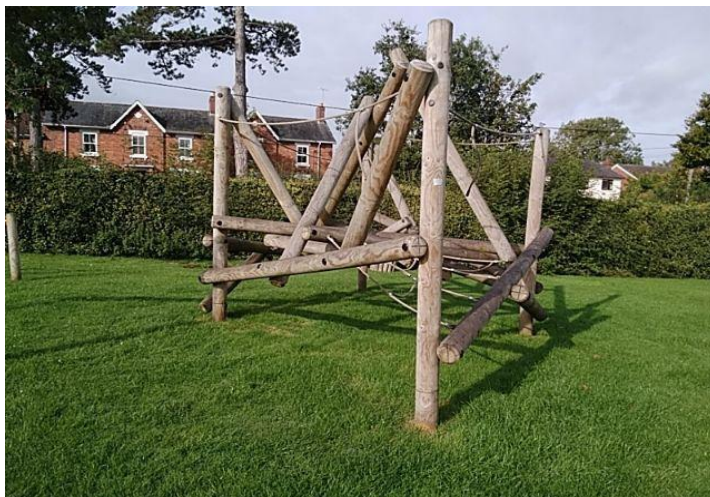
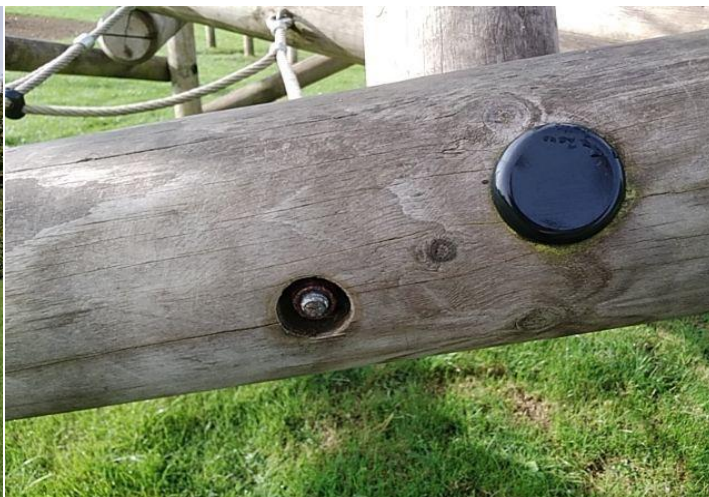
Finding: There is/are bolt cap covers missing or damaged on the item

Action: Replace missing or damaged bolt cap covers

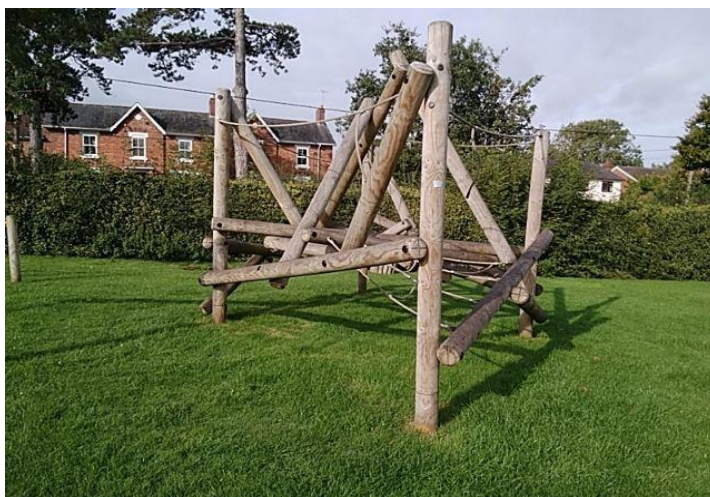
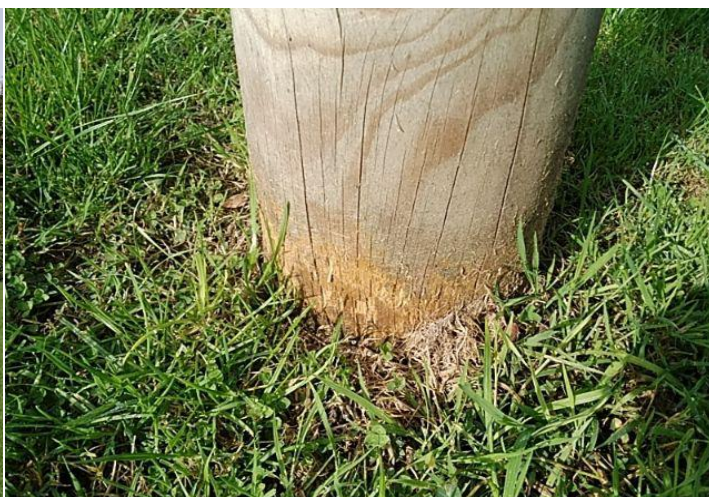
Finding: There is some strimmer / machinery damage apparent on the posts, this can penetrate the preservative applied to the timber and accelerate the rotting process

Action: Monitor for any deterioration (rot) and replace as required

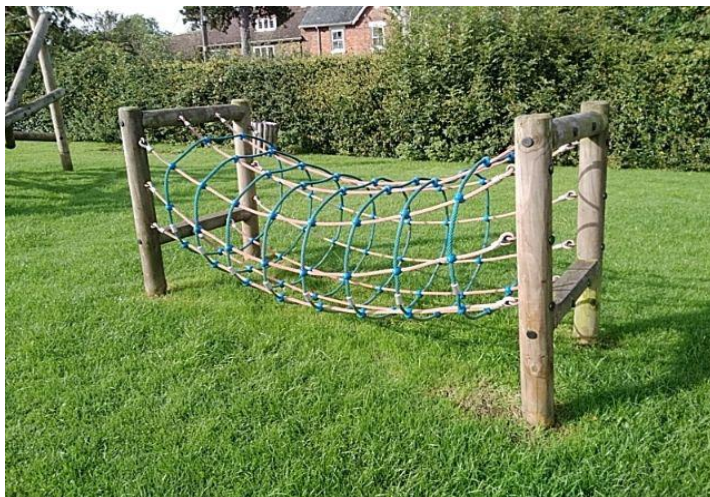
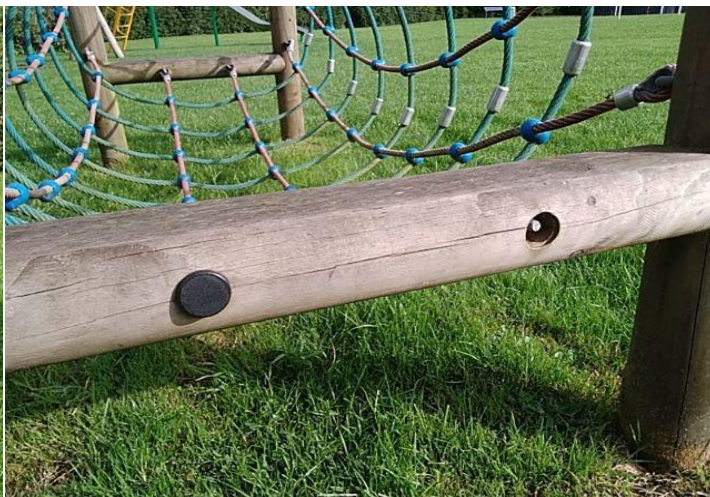
Finding: There is/are bolt cap covers missing or damaged on the item

Action: Replace missing or damaged bolt cap covers

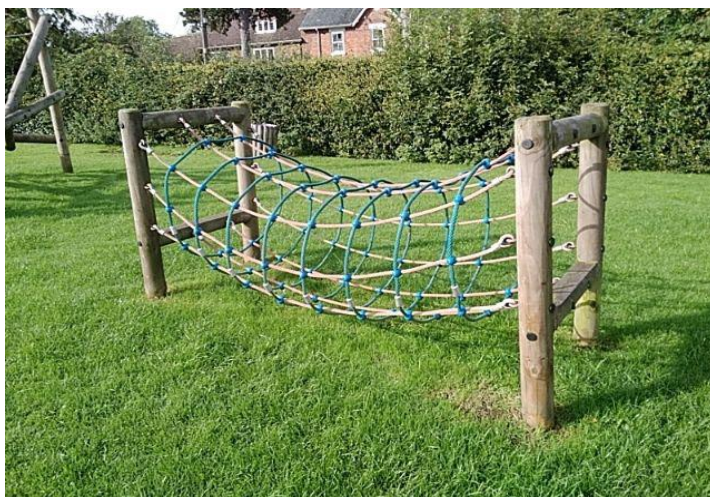
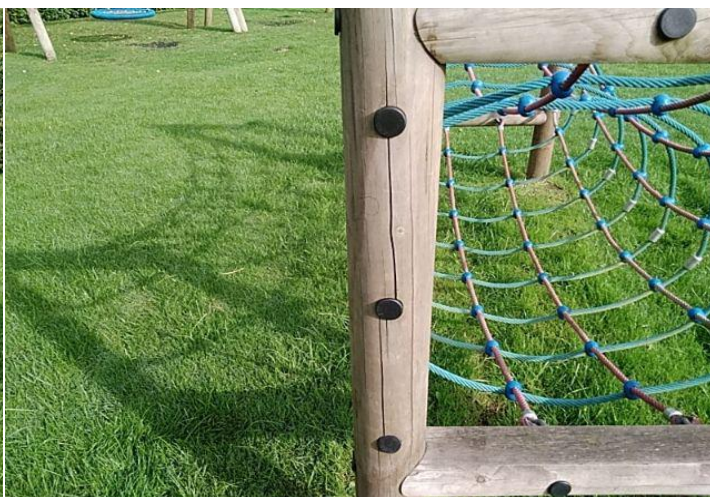
Finding: The timber has a number of splits/shakes or air cracks and this may affect the stability or allow water ingress which will accelerate the rotting process

Action: Monitor to ensure the splits do not cross through fixing points of the structure and/or cause any instability

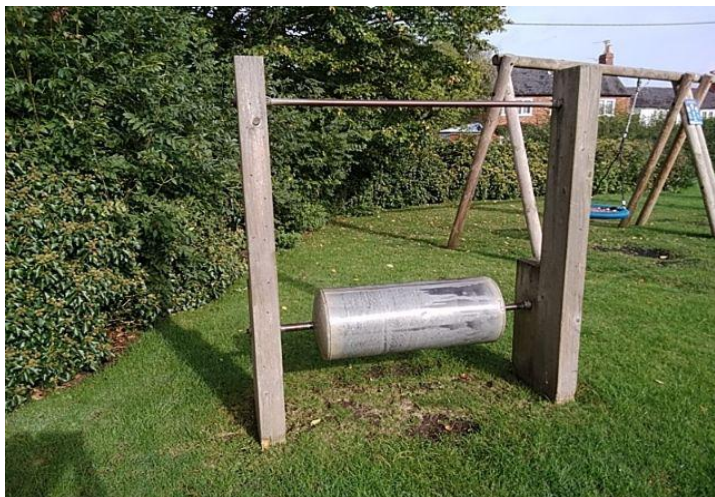
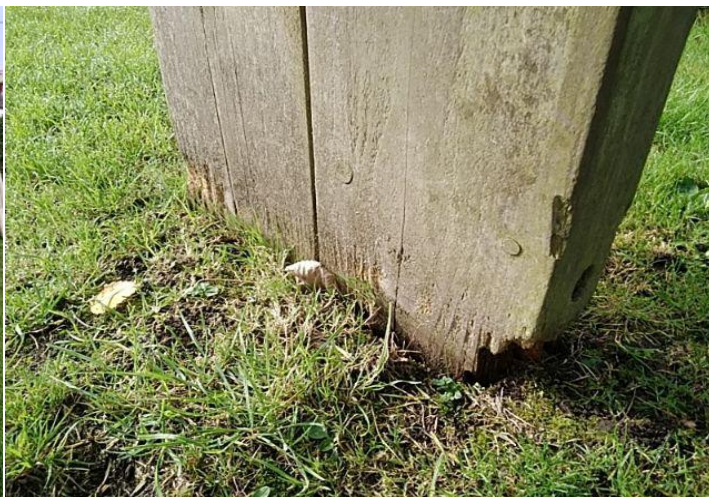
Finding: There is some evidence of rot in the timber

Action: Monitor for any further deterioration and replace as required

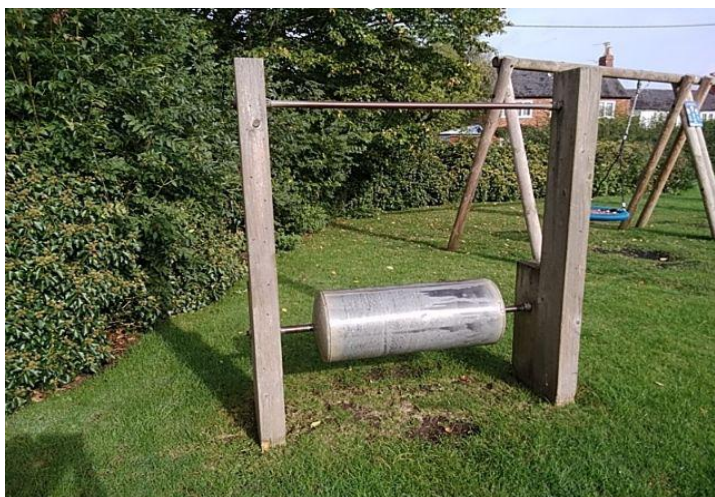
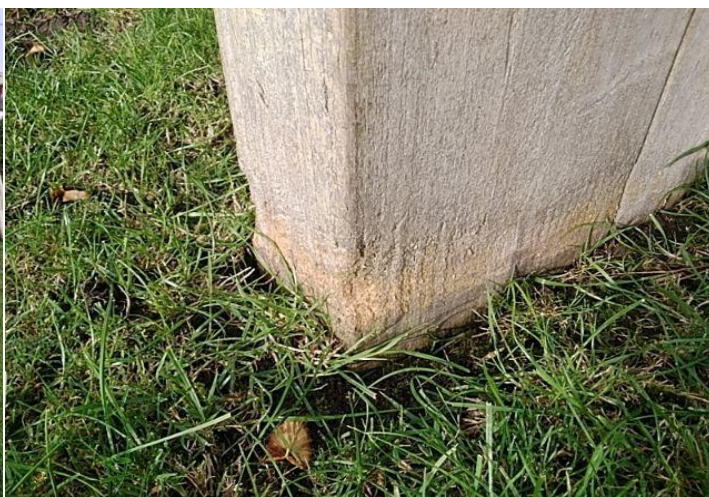
Finding: There is some strimmer / machinery damage apparent on the posts, this can penetrate the preservative applied to the timber and accelerate the rotting process

Action: Monitor for any deterioration (rot) and replace as required

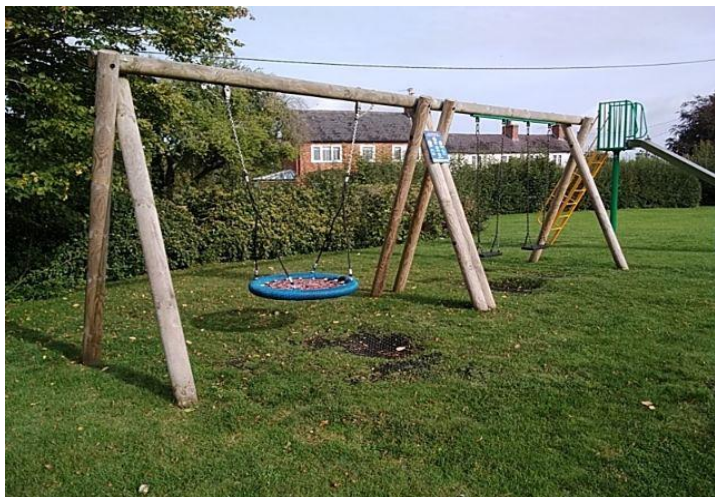
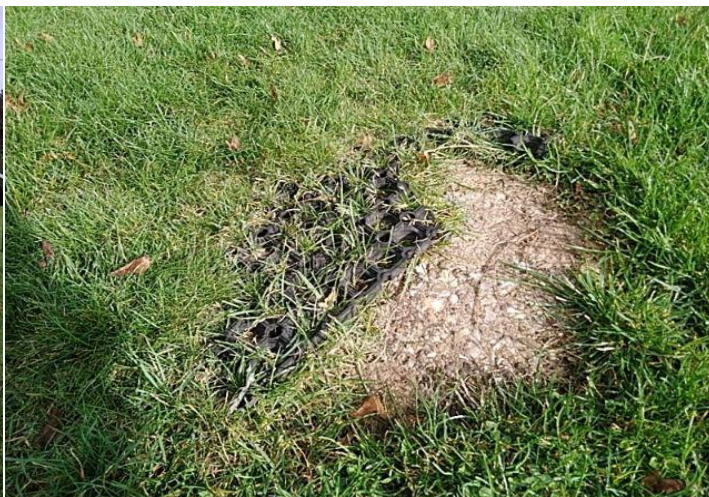
Finding: The edges of the grass mat surface have not been installed in accordance with the API Code of Practice
Action: Tuck in edges of grass mat to remove trip hazards

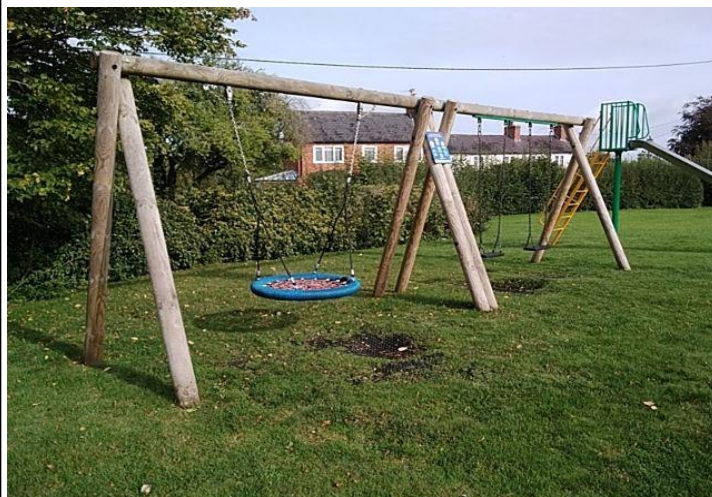
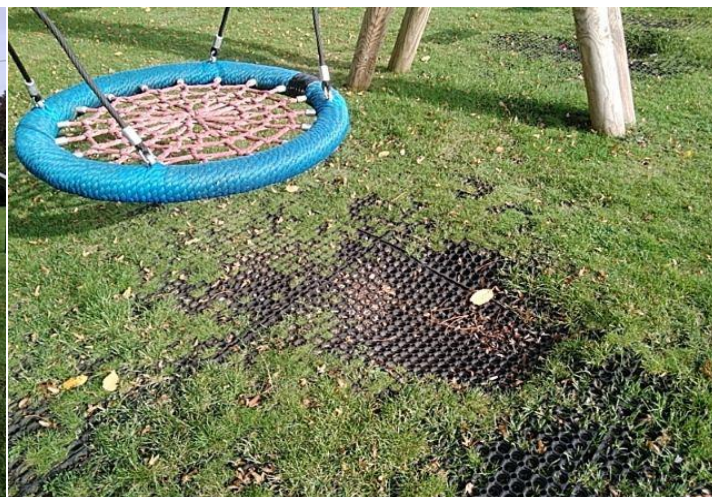
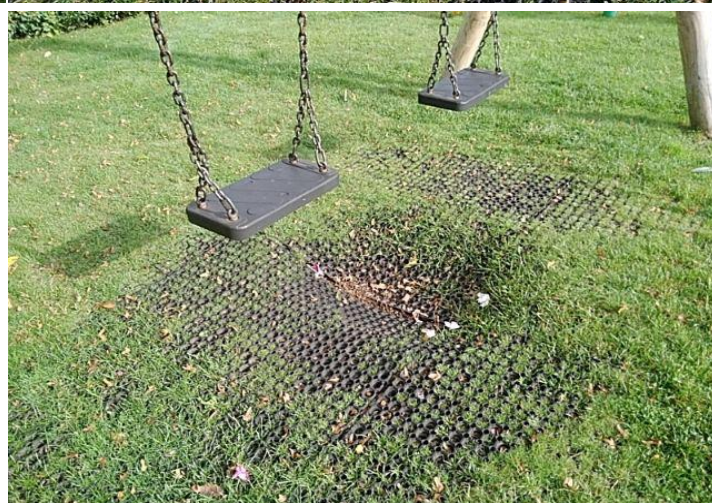
Finding: Large dips in the playing surface

Action: Repair the surface

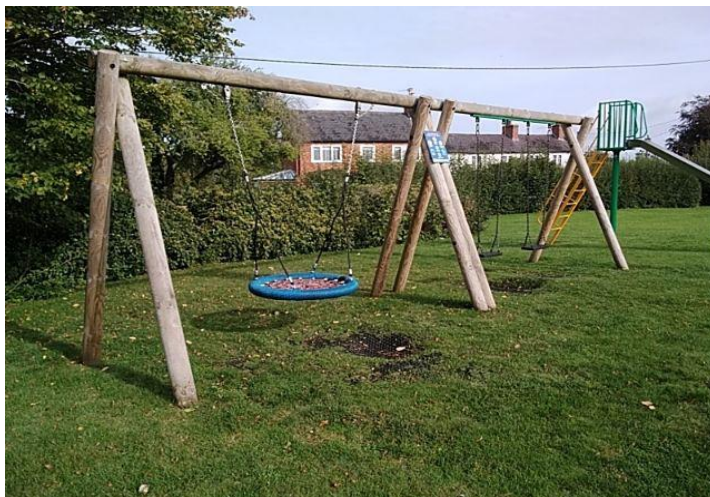
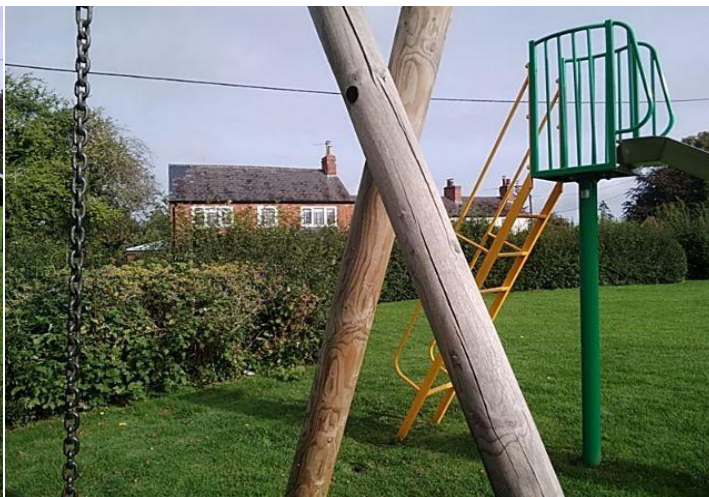
Finding: The timber has a number of splits/shakes or air cracks and this may affect the stability or allow water ingress which will accelerate the rotting process
Action: Monitor to ensure the splits do not cross through fixing points of the structure and/or cause any instability

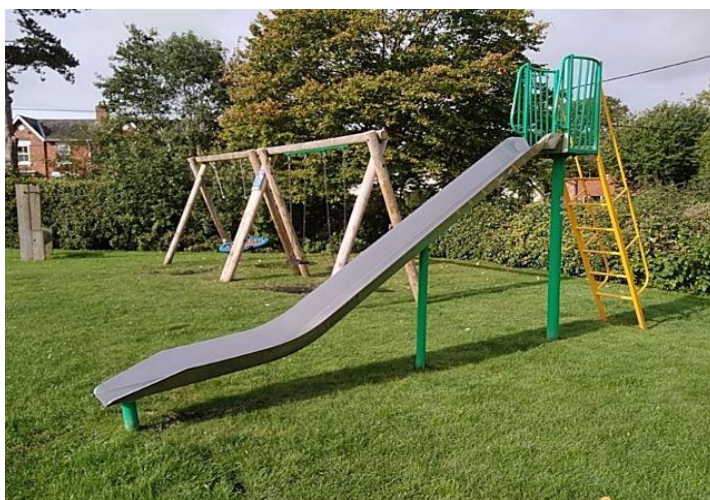
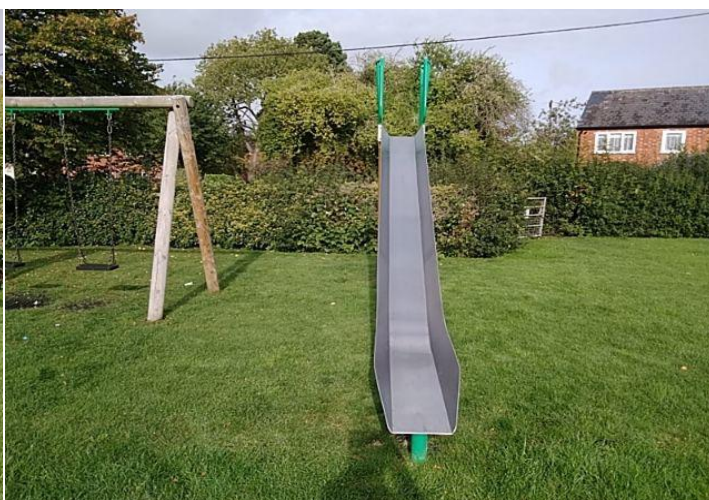
Finding: The slide is predominately south facing and will catch the majority of the sun's heat during the day. Slide surfaces can become very warm during periods of sustained sunny weather
Action: Monitor - No remedial work recommended

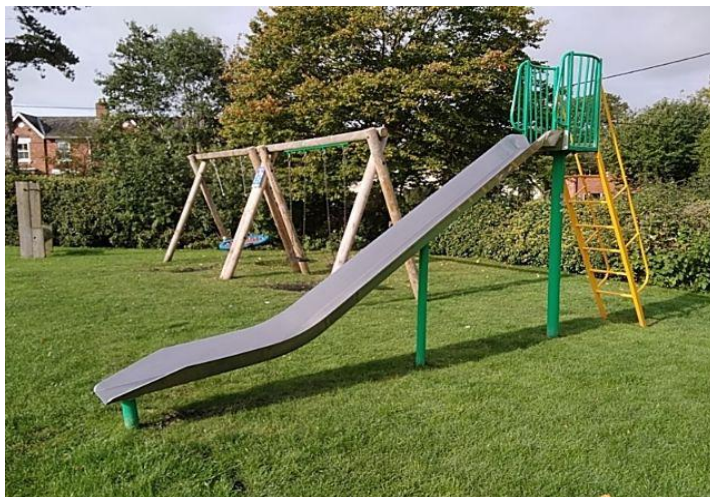
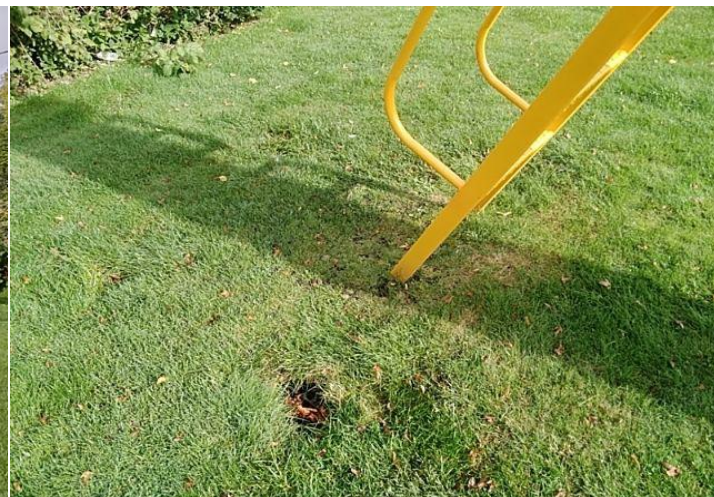
Finding: Hole in the playing surface

Action: Repair the surface

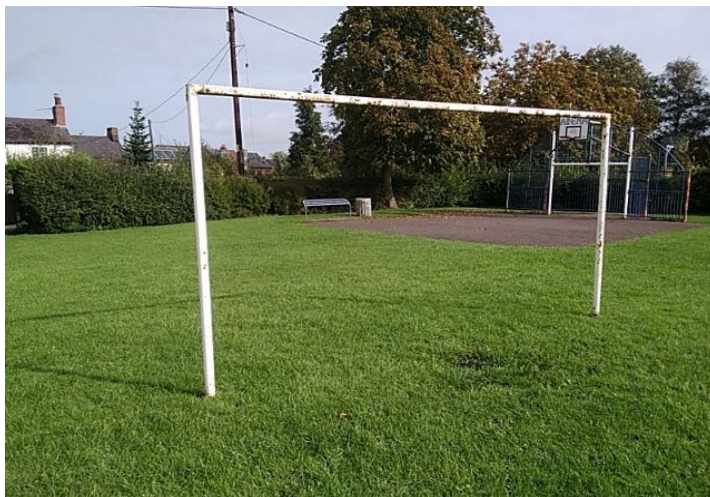
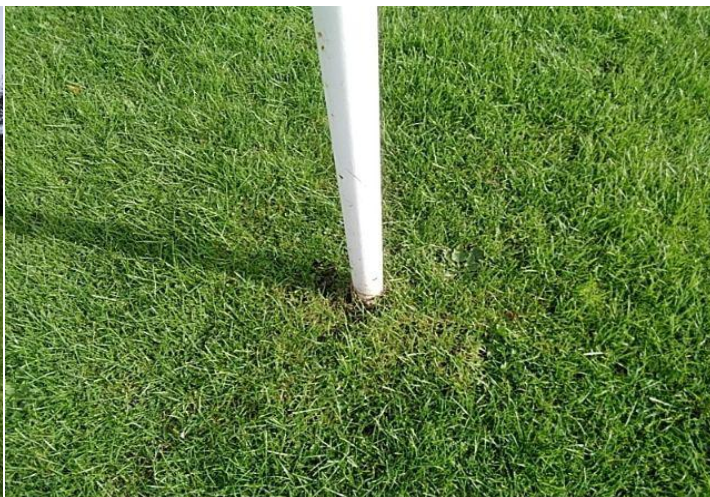
Finding: The item is slightly loose in its foundations

Action: Monitor for any further deterioration and repair as required

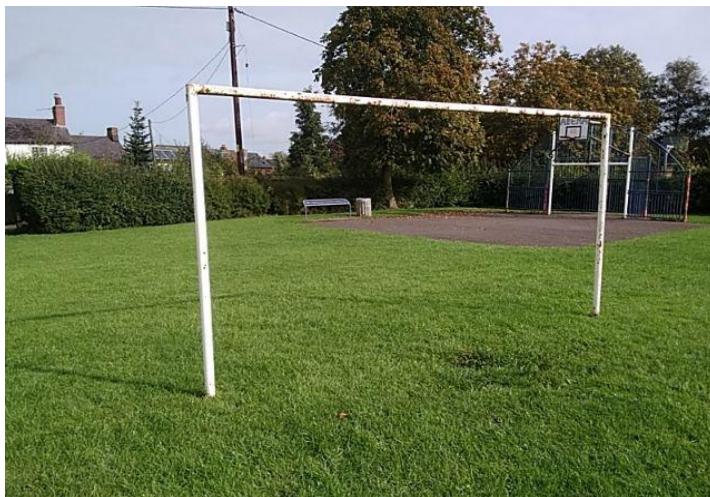
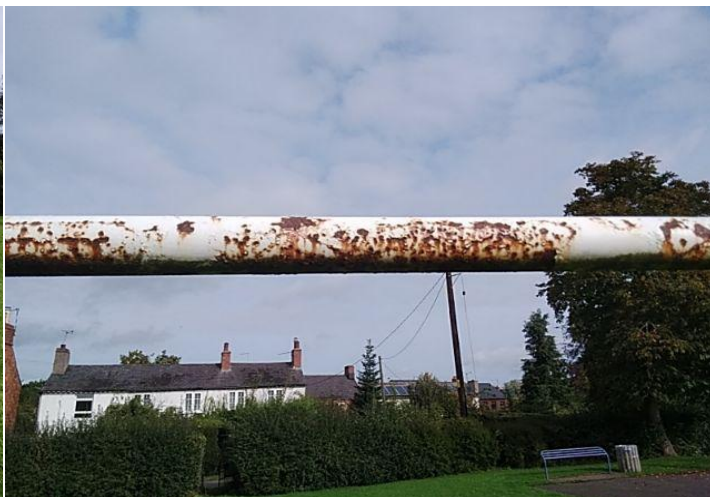
Finding: There is surface corrosion present on the item

Action: Consider treating the item

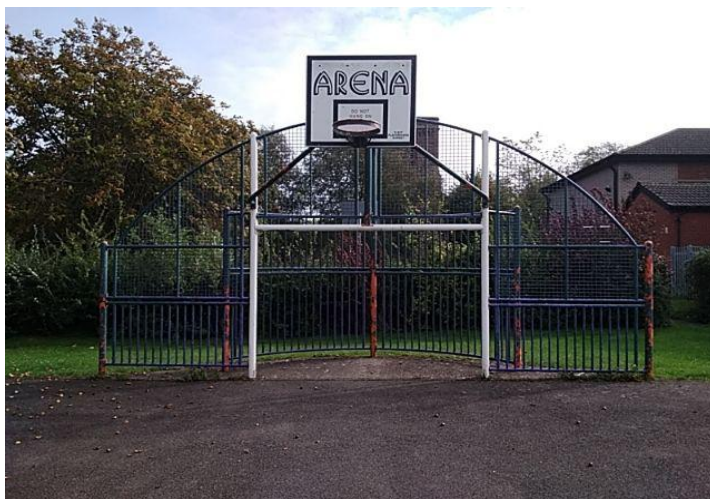
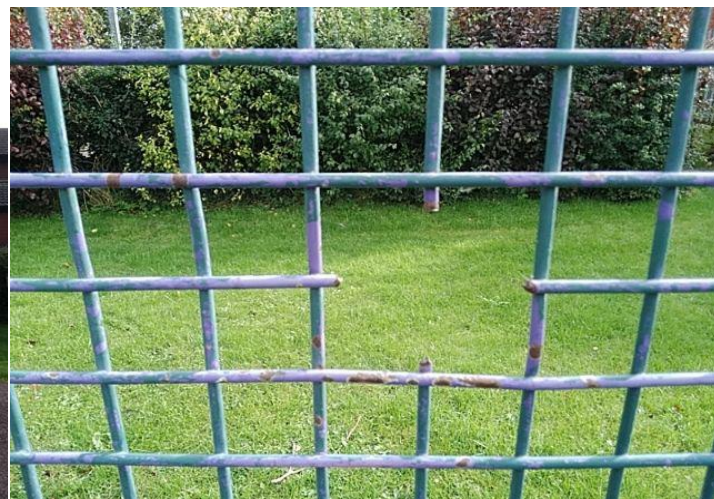
Finding: The item has been damaged

Action: Monitor for any further deterioration and replace as required
