Annual Inspection

Barby & Onley Parish Council

Barby Play Area

Daventry Road, Barby, CV23 8TT

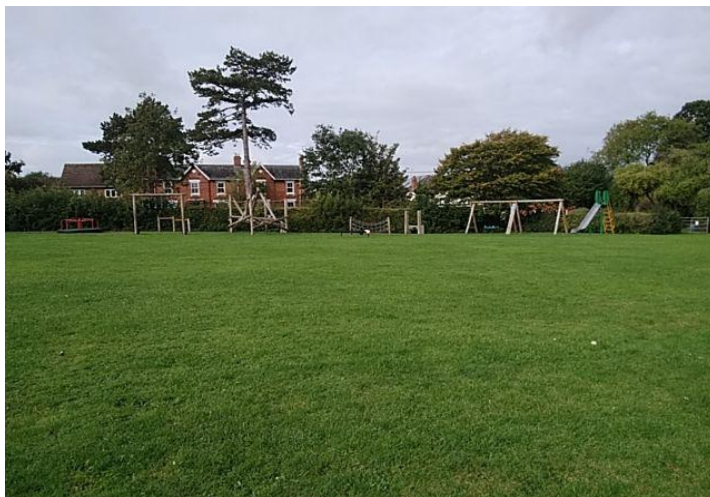
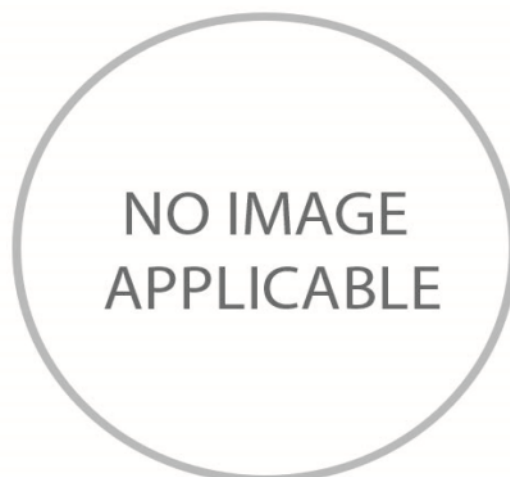
Finding: It is recommended that signage, with information including the site address, contact information for maintenance issues and emergency contact details are provided for the facility

Action: Provide in accordance with the recommendations

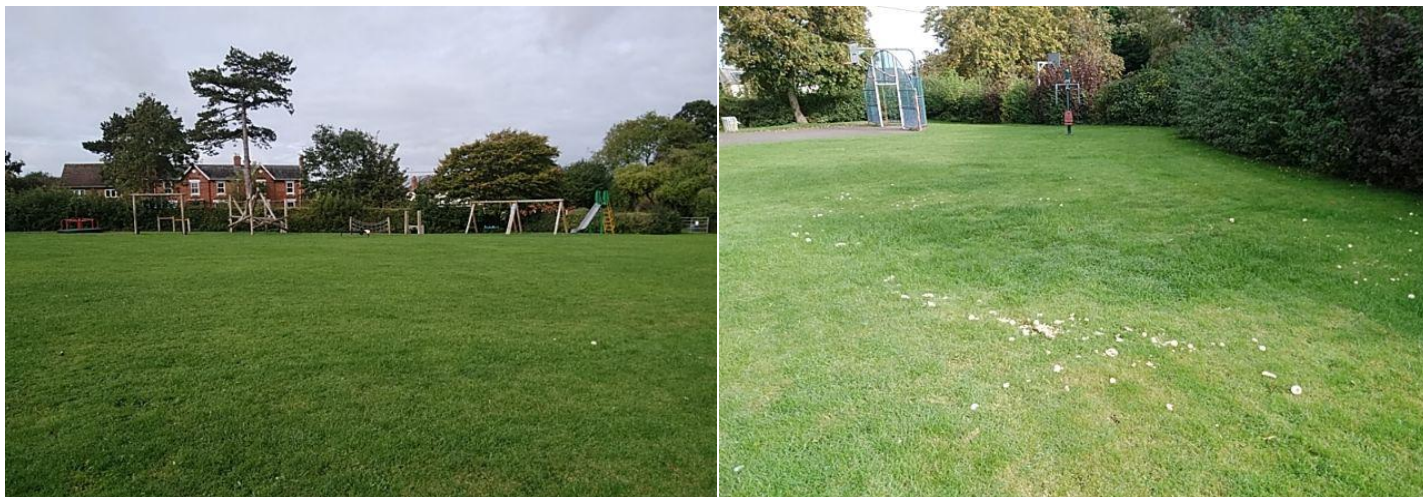
Finding: Fungus was found on site

Action: Remove as required
