Annual Inspection

Barby & Onley Parish Council

Onley Play Area

Inspection Ref: 2186532

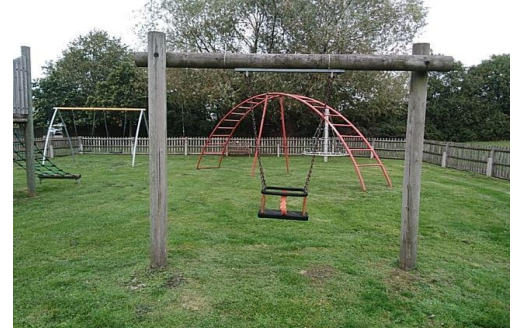
Item: 1 Bay 1 Seat (Cradle) - Type 1
Manufacturer: Playdale Playgrounds Ltd
Surface Type: Grass Matrix Tiles
Item Quantity: 1
Equipment Compliance: N/A
Surface Area Compliance: N/A

The timber has a number of splits/shakes or air cracks and this may affect the stability or allow water ingress which will accelerate the rotting process - Monitor to ensure the splits do not cross through fixing points of the structure and/or cause any instability

There is some evidence of rot in the timber. The swing frame is in generally poor condition - Monitor for any further deterioration and replace as required. Consider replacing the swing frame in the longer term

There is some notable evidence of chain wear - Monitor for any further deterioration and replace when 40% worn

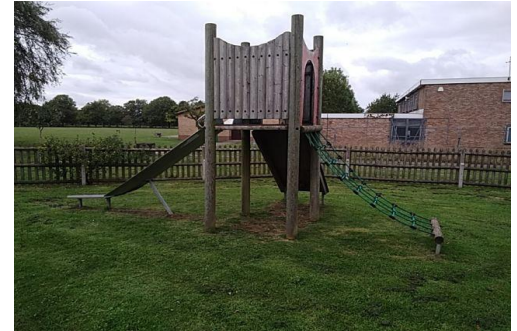
Item: Multi Play (Junior)
Manufacturer: Playdale Playgrounds Ltd
Surface Type: Grass Matrix Tiles
Item Quantity: 1
Equipment Compliance: N/A
Surface Area Compliance: N/A

The rope has worn and wire strands are exposed - Replace rope or net

The access net ground log forms a hard object within the falling space of the equipment in contravention of the requirements of BS EN 1176 Part 1 - Monitor - No remedial work recommended

There are gaps opening between the grass mat tiles - Reinstate surface

The slide is predominately south facing and will catch the majority of the sun's heat during the day. Slide surfaces can become very warm during periods of sustained sunny weather - Monitor - No remedial work recommended

Wear on the edges of the ramp panel and treads - Monitor and replace as required

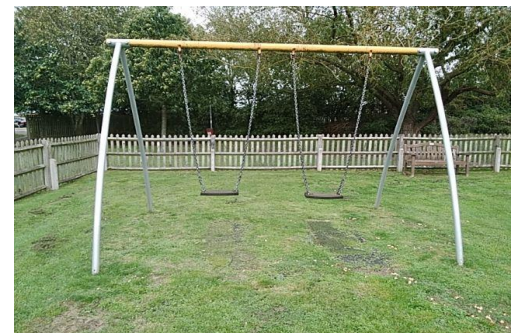
Item: 1 Bay 2 Seat (Flat)
Manufacturer: Unknown
Surface Type: Grass Matrix Tiles
Item Quantity: 1
Equipment Compliance: N/A
Surface Area Compliance: N/A

The surfacing around the item is damaged - Repair the damaged areas of surfacing

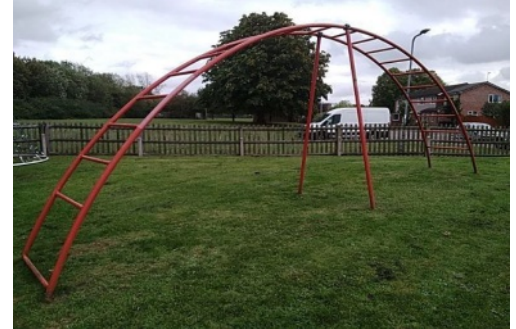
Item: Climbing Frame
Manufacturer: Wicksteed Playgrounds
Surface Type: Grass Matrix Tiles
Item Quantity: 1
Equipment Compliance: N/A
Surface Area Compliance: N/A

This item is satisfactory - no work required -

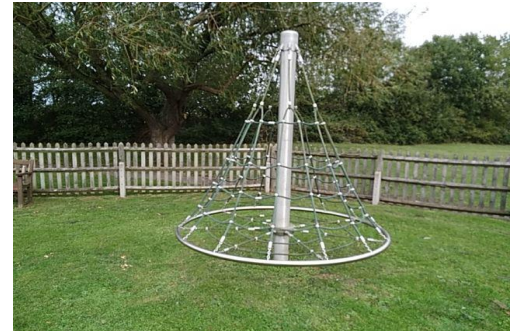
Item: Rotating Net
Manufacturer: Tayplay Ltd
Surface Type: Grass Matrix Tiles
Item Quantity: 1
Equipment Compliance: N/A
Surface Area Compliance: N/A

Fungus was found on site - Remove as required

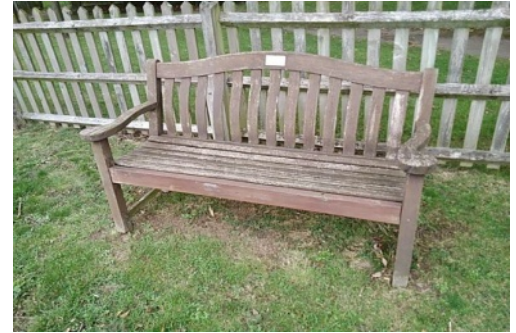
Item: Seat
Manufacturer: Unknown
Surface Type: Grass
Item Quantity: 1
Equipment Compliance: N/A
Surface Area Compliance: N/A

This item is satisfactory - no work required -

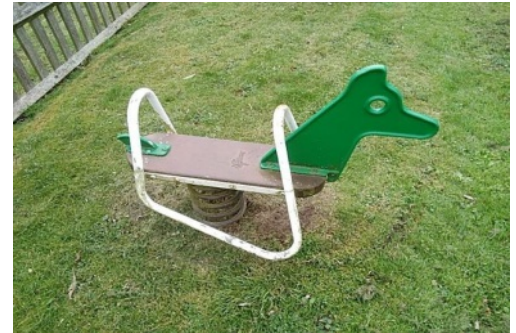
Item: Spring Horse
Manufacturer: Ausplay
Surface Type: Grass
Item Quantity: 1
Equipment Compliance: N/A
Surface Area Compliance: N/A

This item is satisfactory - no work required -

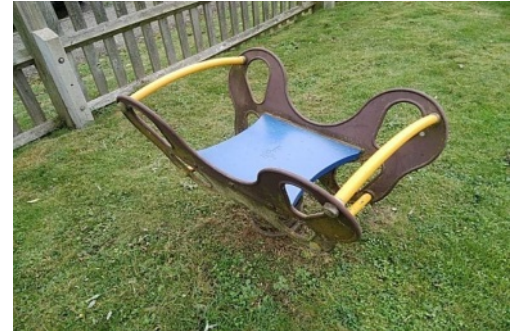
Item: Misc Springer
Manufacturer: Ausplay
Surface Type: Grass
Item Quantity: 1
Equipment Compliance: N/A
Surface Area Compliance: N/A

This item is satisfactory - no work required -

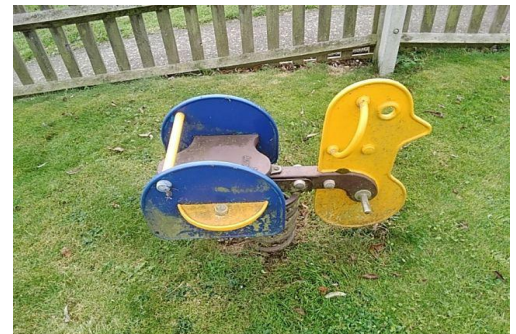
Item: Spring Duck
Manufacturer: Ausplay
Surface Type: Grass
Item Quantity: 1
Equipment Compliance: N/A
Surface Area Compliance: N/A

The end of handgrips and/or footrests have a cross section of less than 15cm² and fail to meet the requirements of BS EN 1176 Part 6 - Monitor - No remedial work recommended

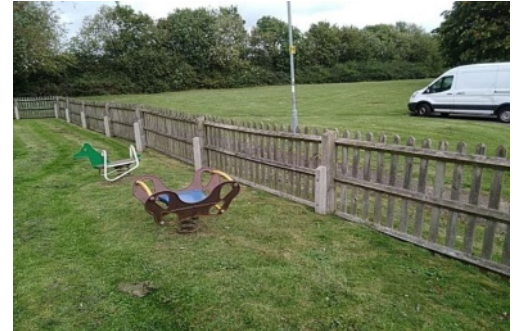
Item: Fencing - Timber
Manufacturer: Unknown
Surface Type: Grass
Item Quantity: 1
Equipment Compliance: N/A
Surface Area Compliance: N/A

This item is satisfactory - no work required -

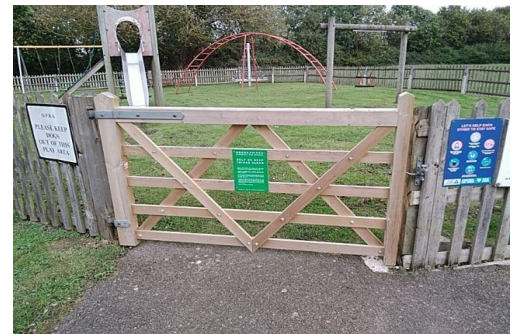
Item: Gate
Manufacturer: Unknown
Surface Type: Mixed Surface
Item Quantity: 1
Equipment Compliance: N/A
Surface Area Compliance: N/A

The gate is snagging on the surrounding surface preventing it from closing correctly - Carry out remedial works to ensure the gate closes correctly

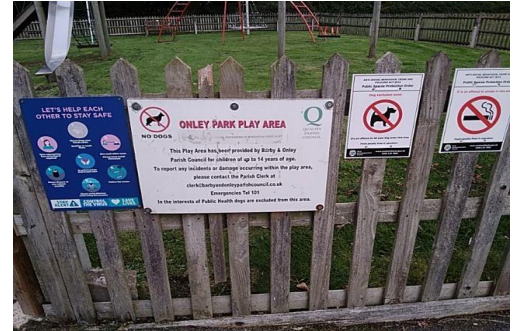
Item: Playground Sign
Manufacturer: Unknown
Surface Type: N/A
Item Quantity: 1
Equipment Compliance: N/A
Surface Area Compliance: N/A

The emergency contact number should be 999 or 112 - Change the number on the sign

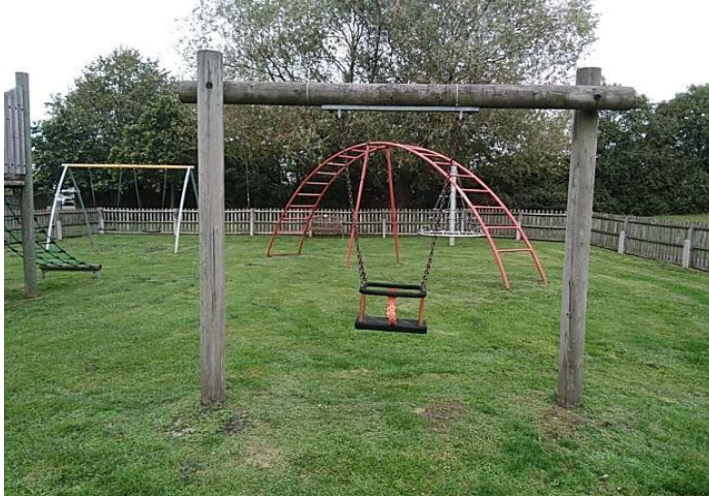
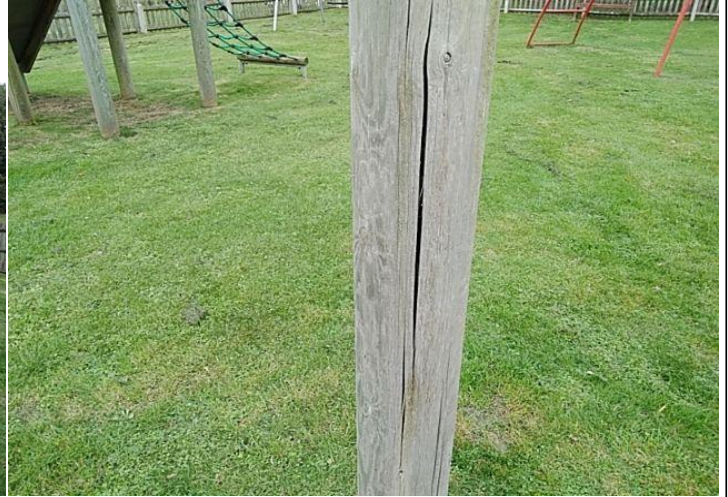
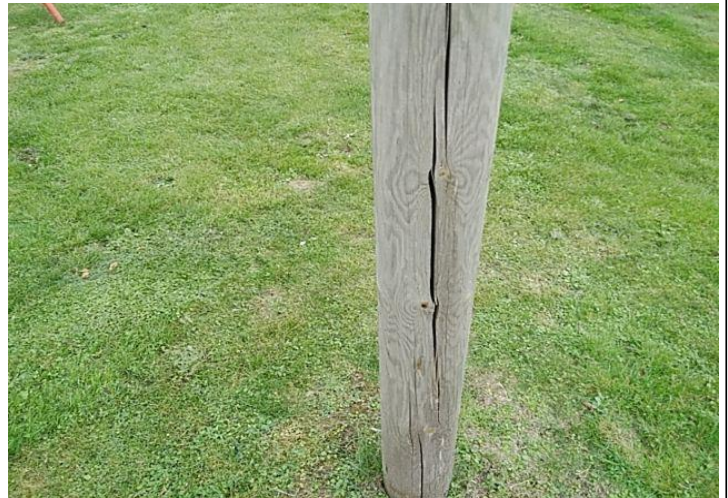
6 - Low Risk (Finding 1)

Finding: The timber has a number of splits/shakes or air cracks and this may affect the stability or allow water ingress which will accelerate the rotting process

Action: Monitor to ensure the splits do not cross through fixing points of the structure and/or cause any instability

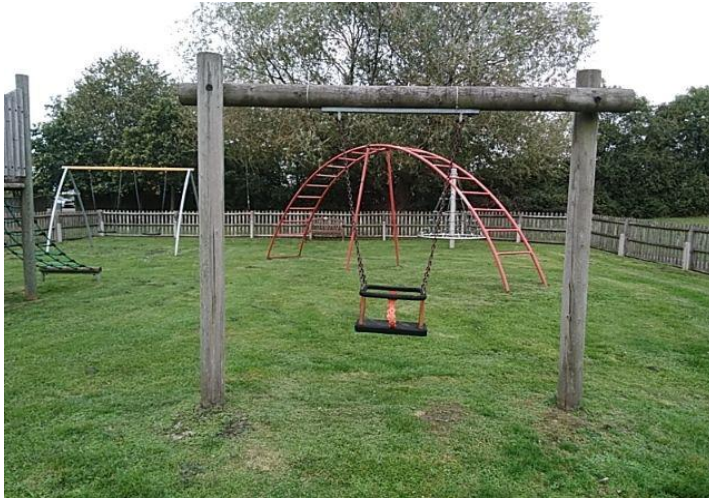
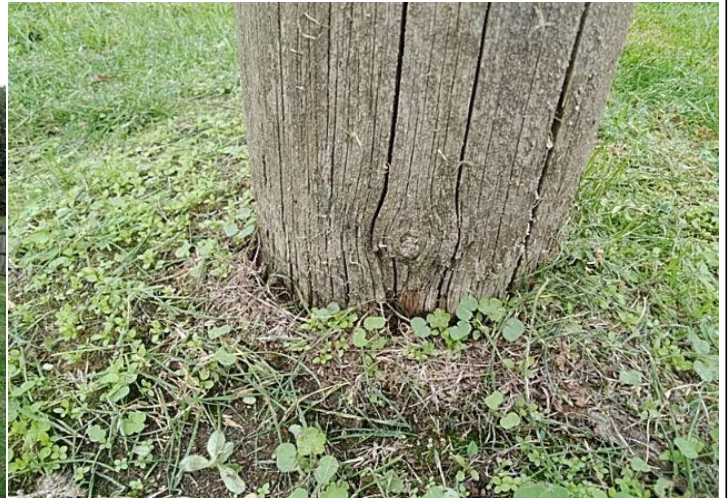
i 10 - Low Risk (Finding 2)

Finding: There is some evidence of rot in the timber. The swing frame is in generally poor condition

Action: Monitor for any further deterioration and replace as required. Consider replacing the swing frame in the longer term

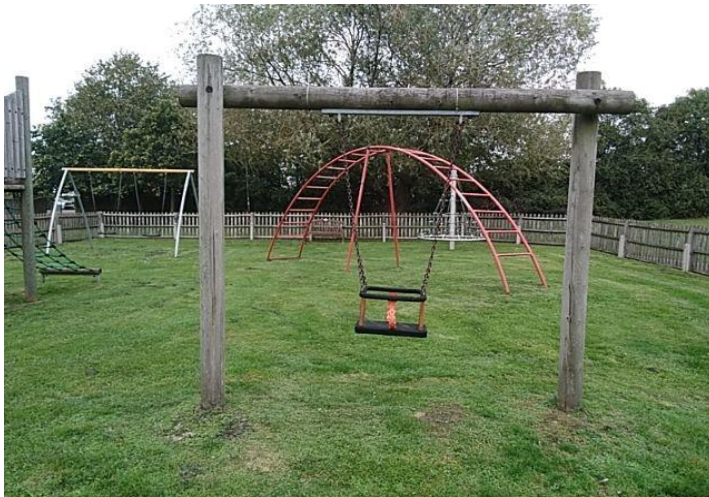
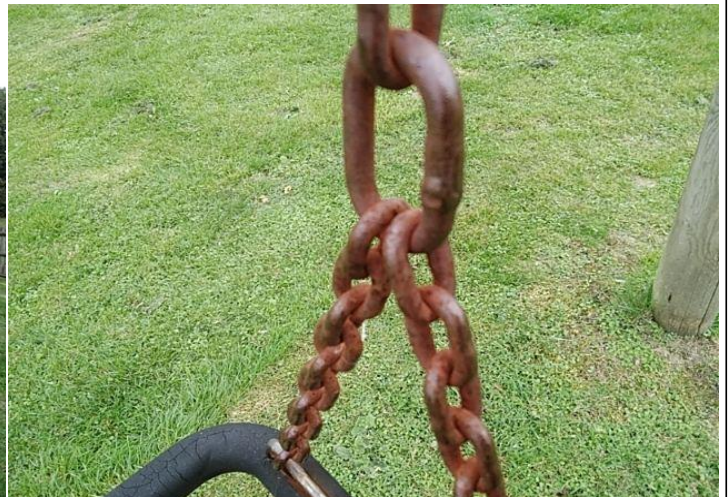
i 6 - Low Risk (Finding 3)

Finding: There is some notable evidence of chain wear

Action: Monitor for any further deterioration and replace when 40% worn

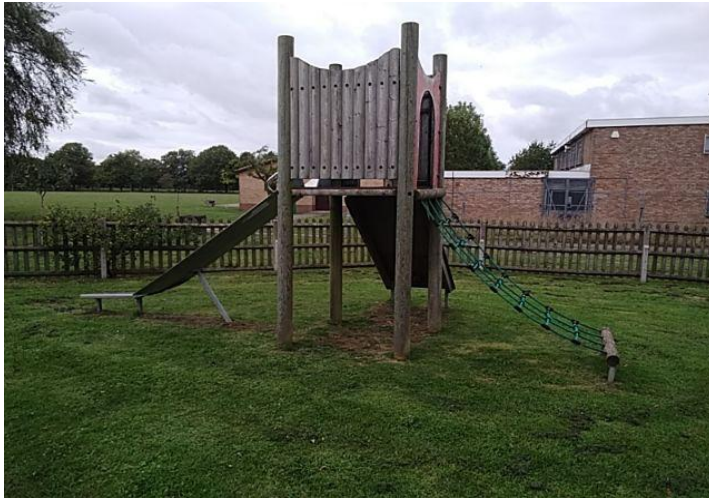
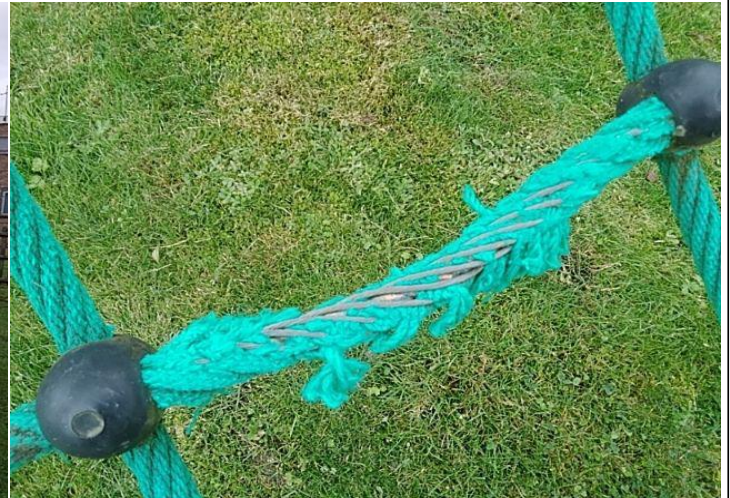
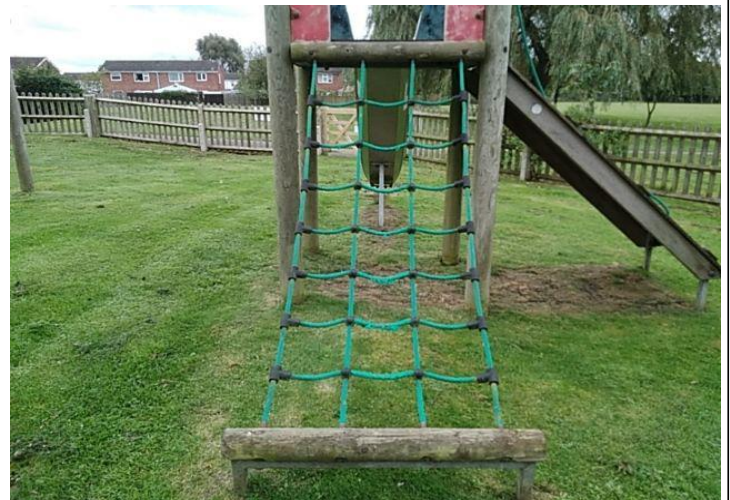
9 - Low Risk (Finding 1)

Finding: The rope has worn and wire strands are exposed

Action: Replace rope or net

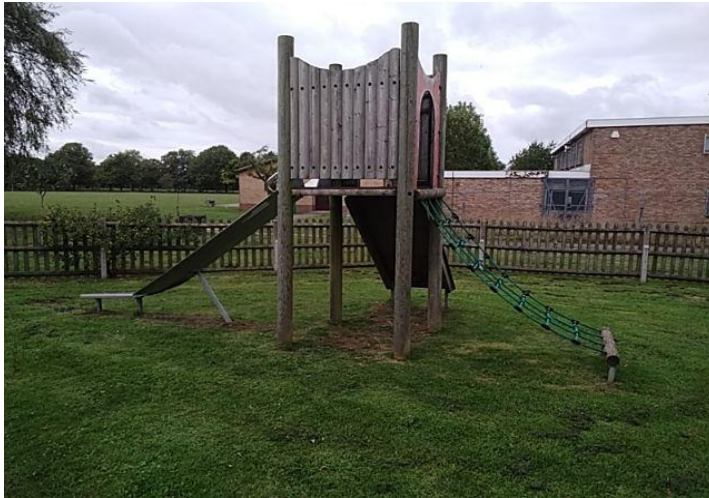
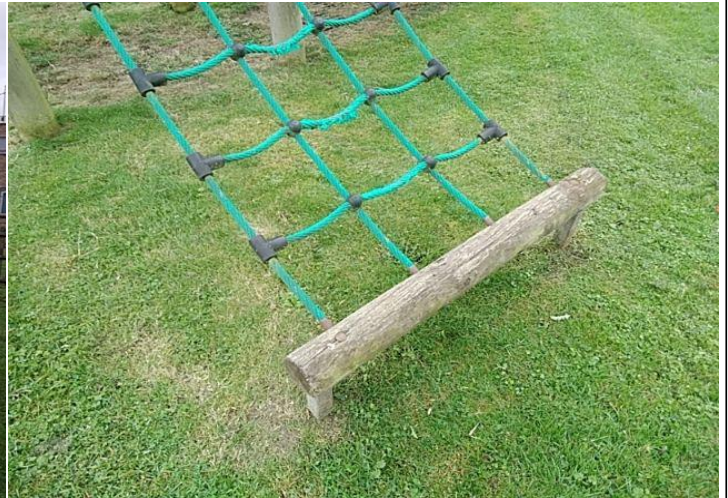
i 5 - Very Low Risk (Finding 2)

Finding: The access net ground log forms a hard object within the falling space of the equipment in contravention of the requirements of BS EN 1176 Part 1

Action: Monitor - No remedial work recommended

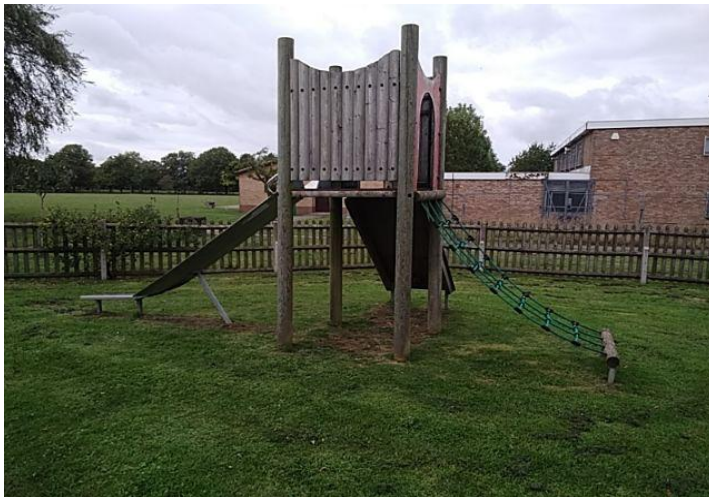
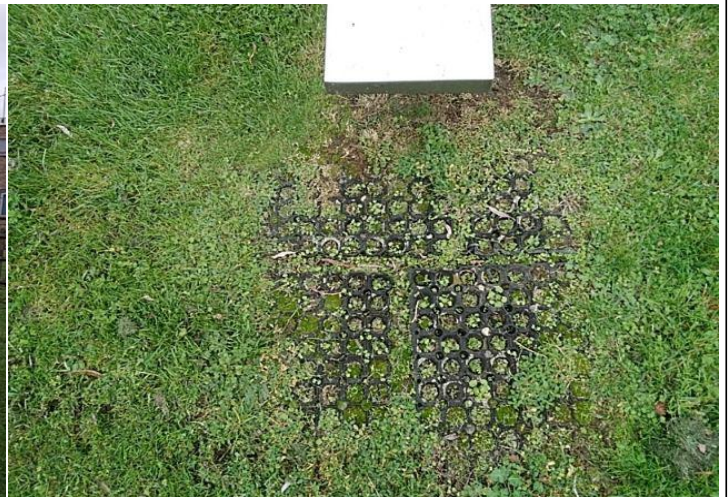
i 6 - Low Risk (Finding 3)

Finding: There are gaps opening between the grass mat tiles

Action: Reinstate surface

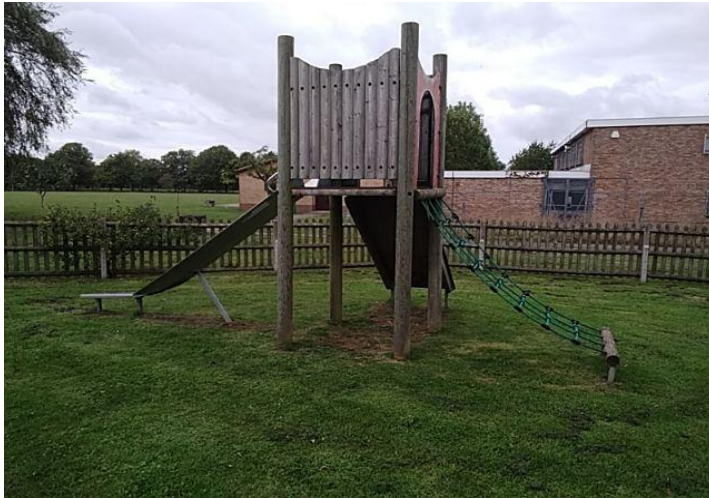
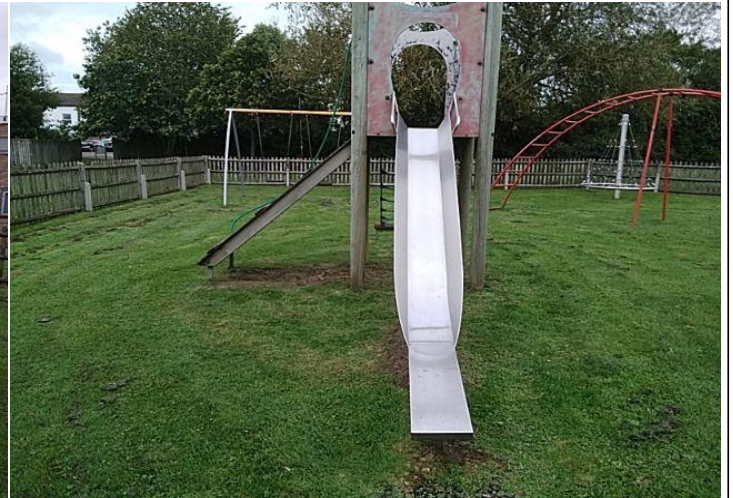
6 - Low Risk (Finding 4)

Finding: The slide is predominately south facing and will catch the majority of the sun's heat during the day. Slide surfaces can become very warm during periods of sustained sunny weather

Action: Monitor - No remedial work recommended

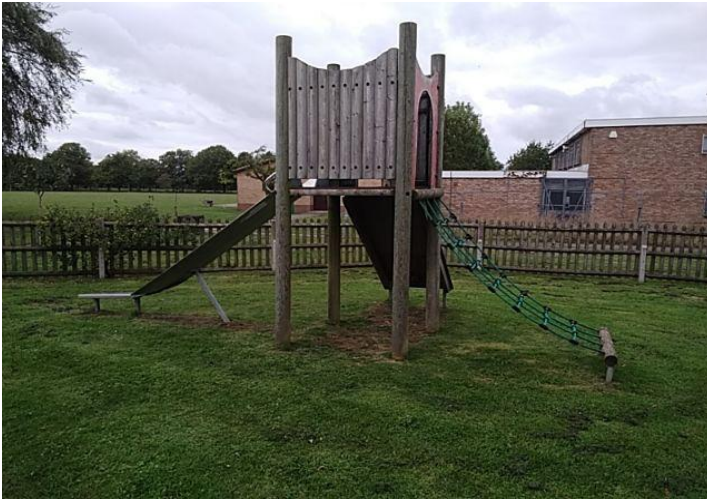
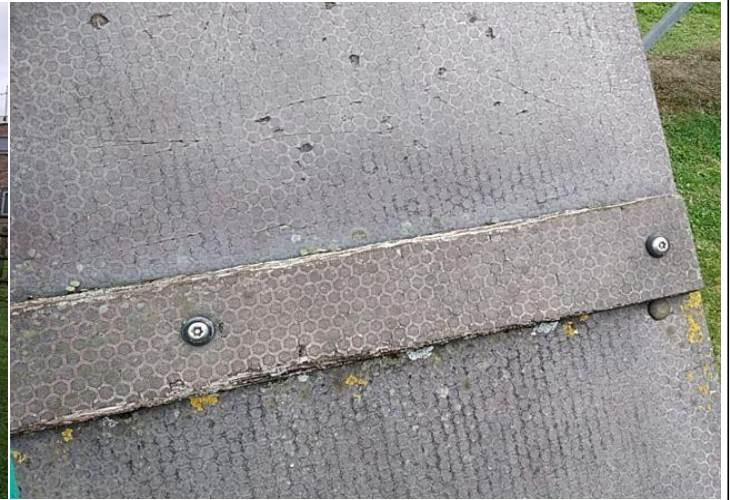
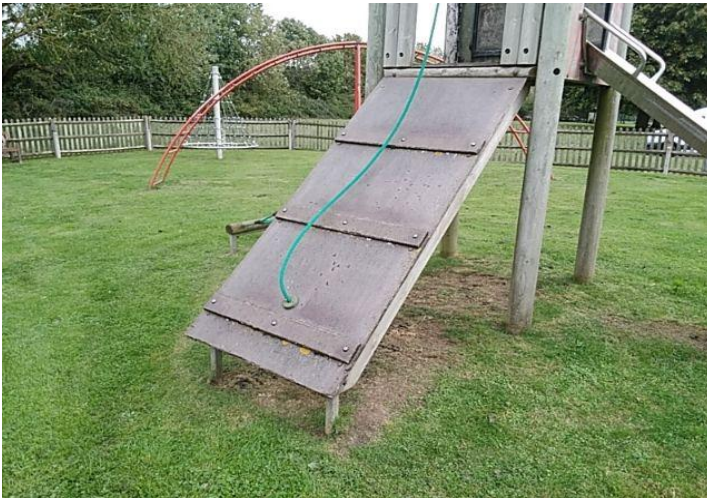
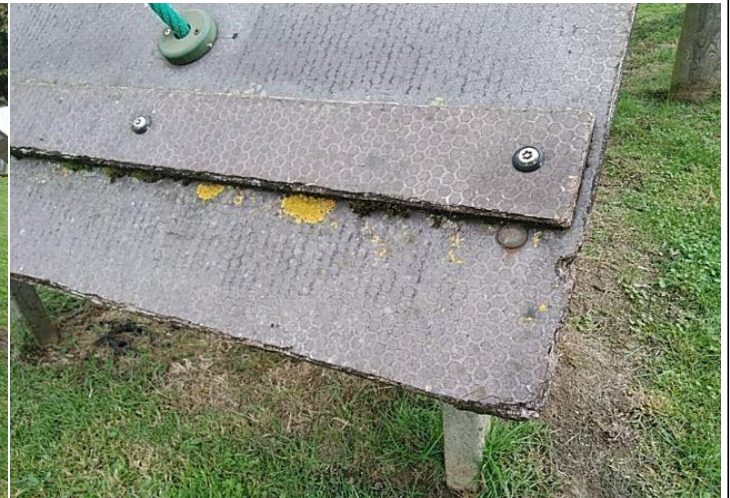
6 - Low Risk (Finding 5)

Finding: Wear on the edges of the ramp panel and treads

Action: Monitor and replace as required

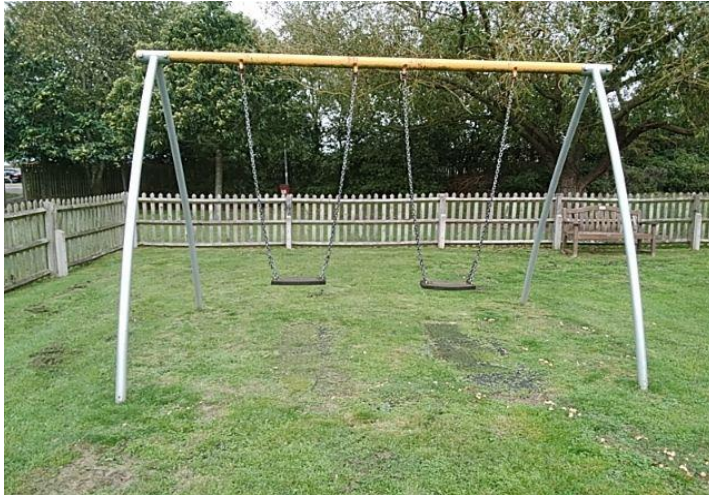
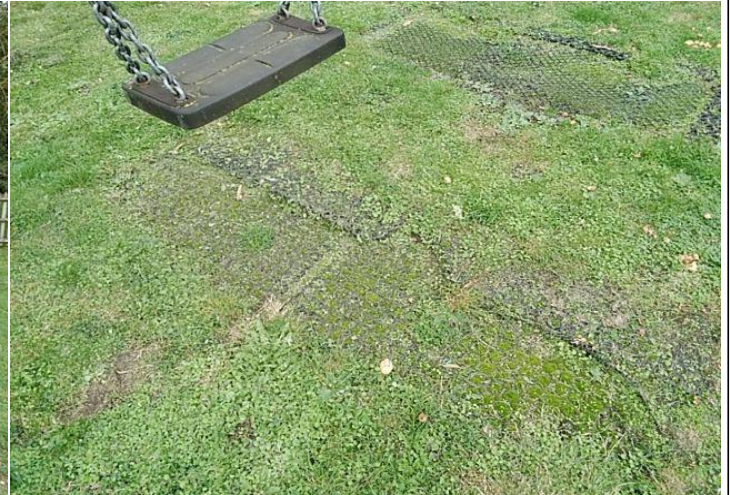
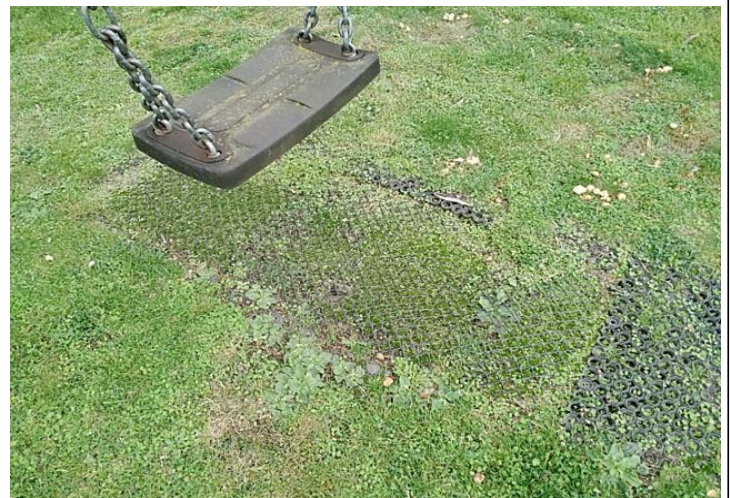
12 - Moderate Risk (Finding 1)

Finding: The surfacing around the item is damaged

Action: Repair the damaged areas of surfacing

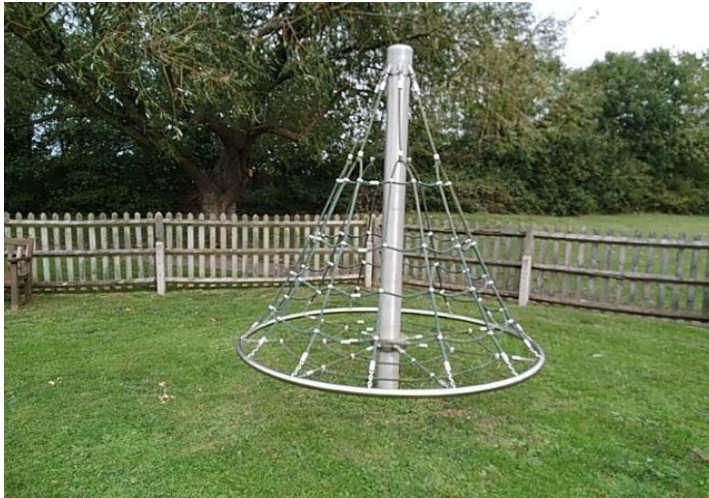
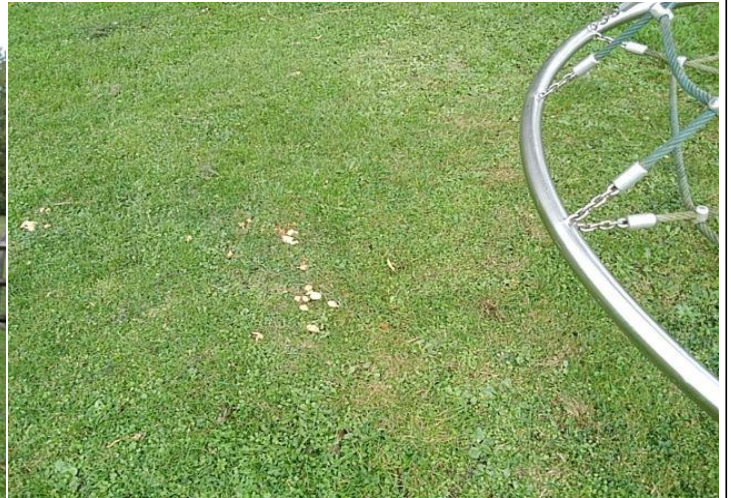
i 5 - Very Low Risk (Finding 1)

Finding: Fungus was found on site

Action: Remove as required

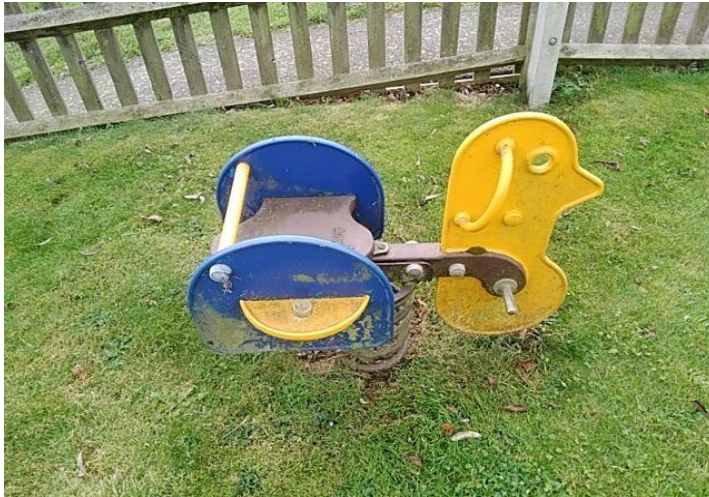
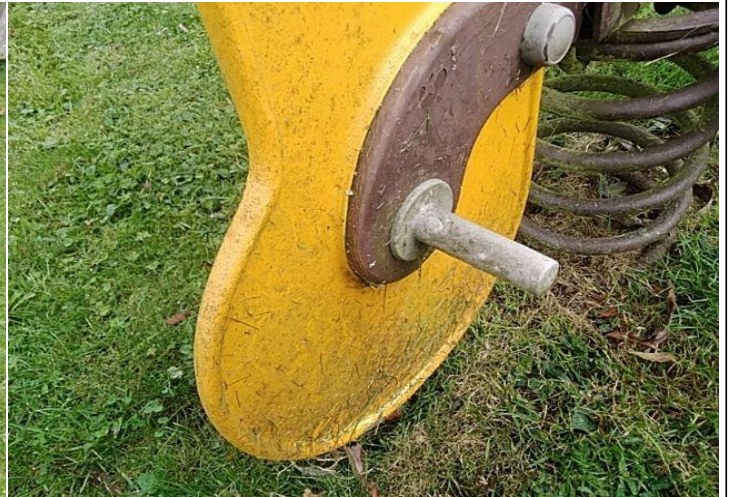
i 6 - Low Risk (Finding 1)

Finding: The end of handgrips and/or footrests have a cross section of less than 15cm² and fail to meet the requirements of BS EN 1176 Part 6

Action: Monitor - No remedial work recommended

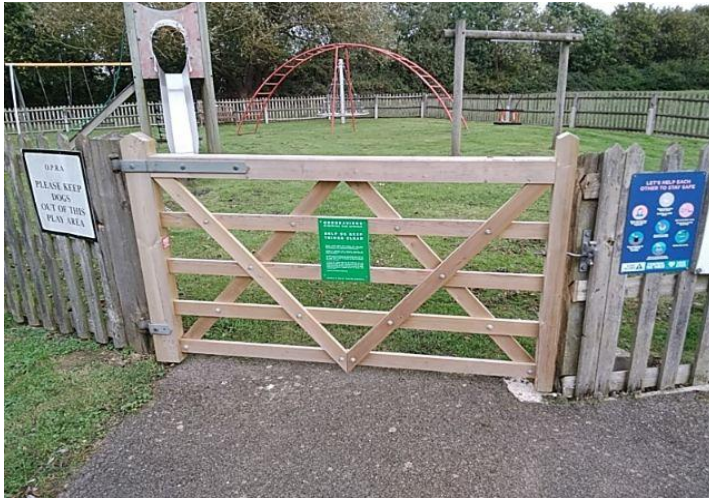
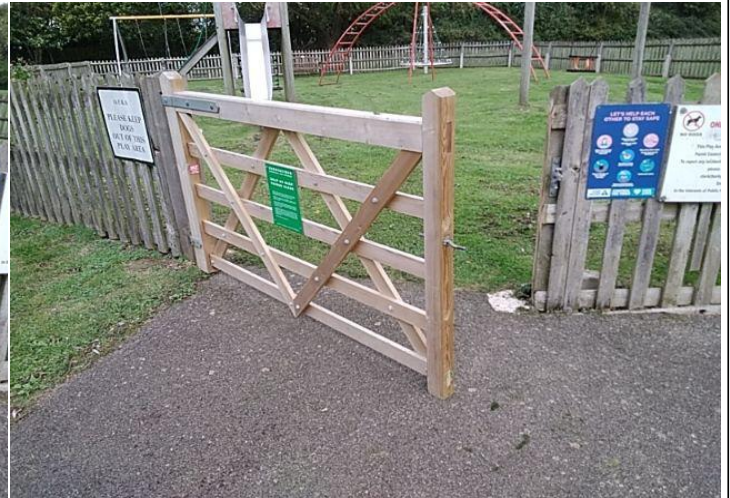
i 5 - Very Low Risk (Finding 1)

Finding: The gate is snagging on the surrounding surface preventing it from closing correctly

Action: Carry out remedial works to ensure the gate closes correctly

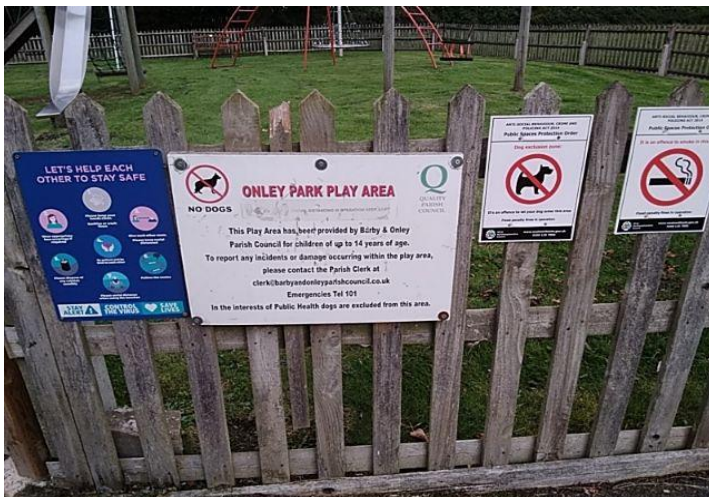
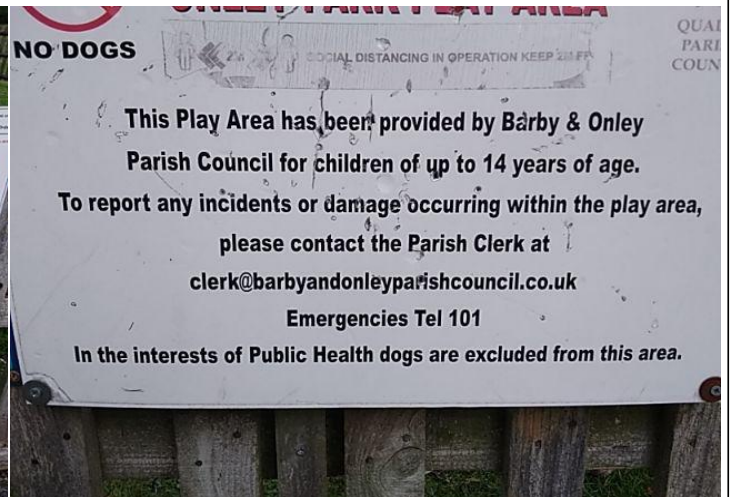
i 0 - Risk Assessment not Undertaken (Finding 1)

Finding: The emergency contact number should be 999 or 112

Action: Change the number on the sign
