Annual Inspection

Barby & Onley Parish Council

Barby Village Hall Play Area

Inspected: 29-October-2024 - 08:39 by Michael Allbright

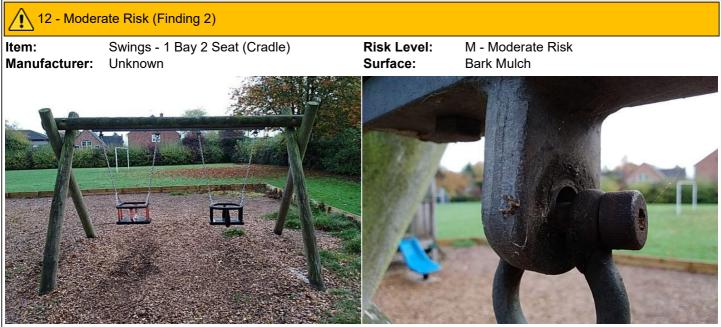
Finding: The bushes are worn or missing

Action: Replace worn or missing bushes

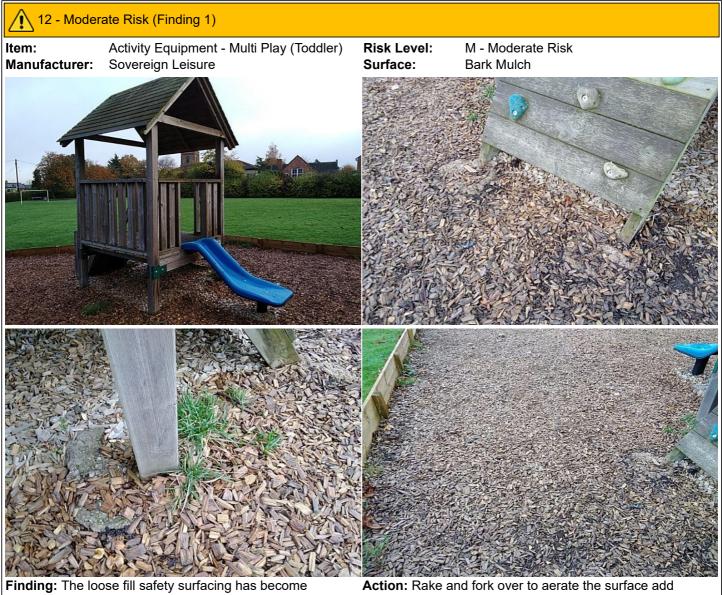
compacted concrete visible

material as required

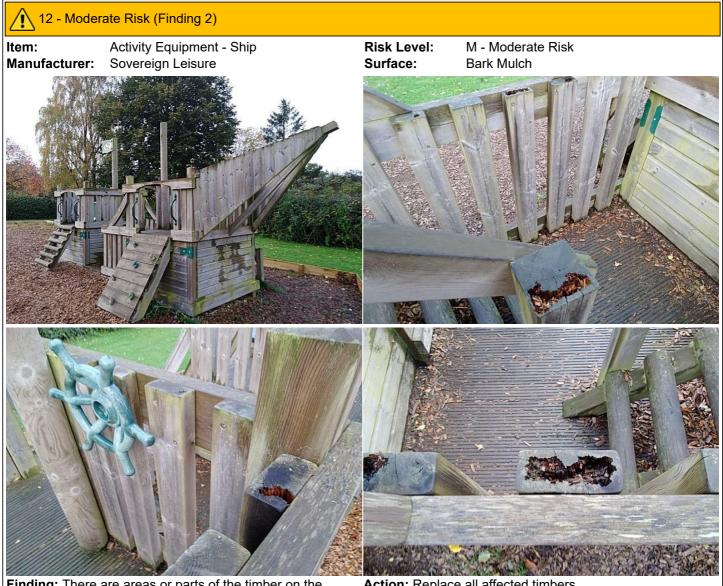
Finding: There are areas or parts of the timber on the structure that have rotted

Action: Replace all affected timbers

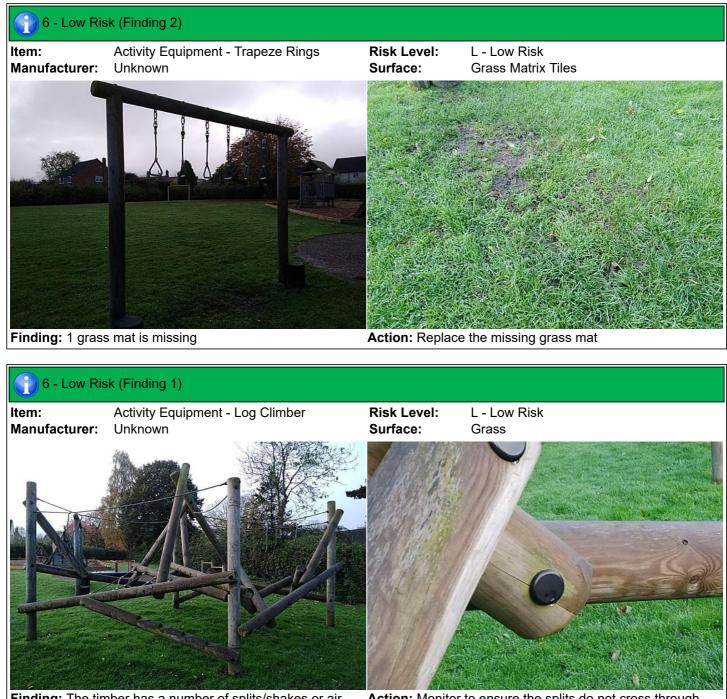
Finding: The timber has a number of splits/shakes or air cracks and this may affect the stability or allow water ingress fixing points of the structure and/or cause any instability which will accelerate the rotting process

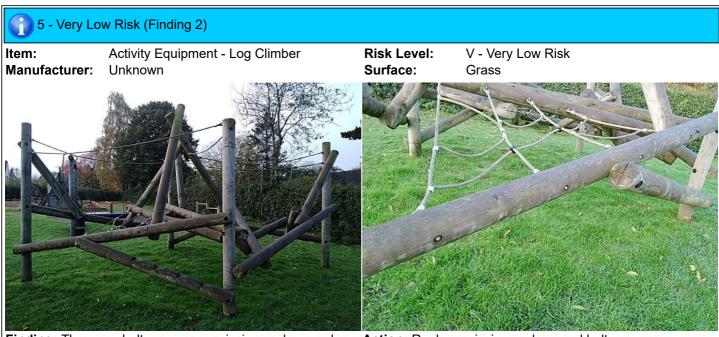
Finding: There are bolt cap covers missing or damaged on **Action:** Replace missing or damaged bolt cap covers the item

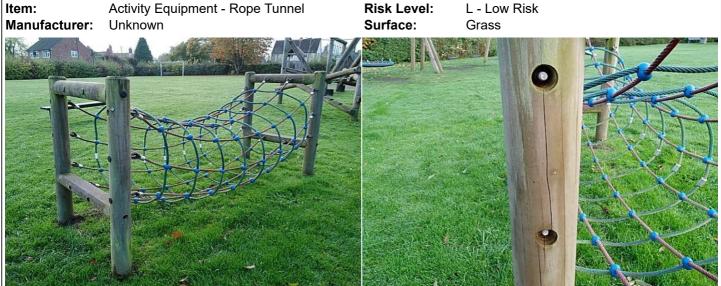
6 - Low Risk (Finding 2) Item: Activity Equipment - Rope Tunnel

Finding: The timber has a number of splits/shakes or air **Action:** Monitor to ensure the splits do not cross through cracks and this may affect the stability or allow water ingress fixing points of the structure and/or cause any instability which will accelerate the rotting process

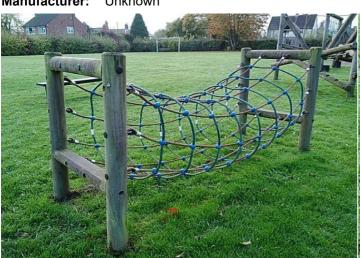
6 - Low Risk (Finding 3)

Finding: There is some strimmer / machinery damage apparent on the posts, this can penetrate the preservative applied to the timber and accelerate the rotting process
