Annual Inspection

Barby & Onley Parish Council

Onley Play Area

Inspection Ref: 2522617 Site Ref: 90999
Property Ref:1267033-425810 Service Object Ref:

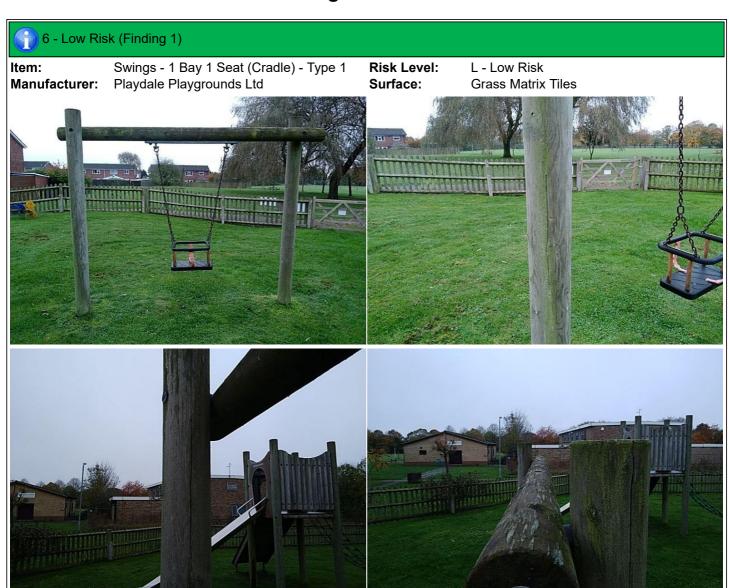
The timber has a number of splits/shakes or air cracks and this may affect the stability or allow water ingress which will accelerate the rotting process - Monitor to ensure the splits do not cross through fixing points of the structure and/or cause any instability

Finding: The timber has a number of splits/shakes or air Action: Monitor to ensure the splits do not cross through cracks and this may affect the stability or allow water ingress fixing points of the structure and/or cause any instability which will accelerate the rotting process

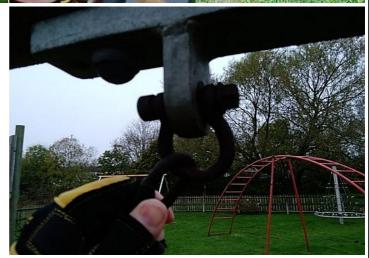
There is some notable evidence of chain wear - Monitor for any further deterioration and replace when 40% worn

Finding: There is some notable evidence of chain wear

Action: Monitor for any further deterioration and replace when 40% worn

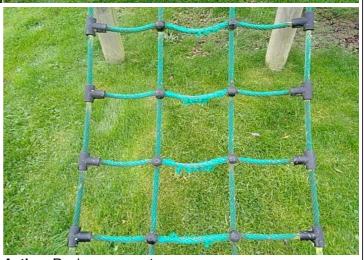
The rope net has worn and wire strands are exposed -

Finding: The rope net has worn and wire strands are exposed

Replace rope net

Action: Replace rope net

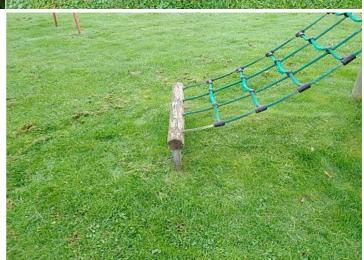
The access net ground log forms a hard object within the falling space of the equipment in contravention of the requirements of BS EN 1176 Part 1 - Monitor - Refer to manufacturer

Finding: The access net ground log forms a hard object within the falling space of the equipment in contravention of the requirements of BS EN 1176 Part 1

Action: Monitor - Refer to manufacturer

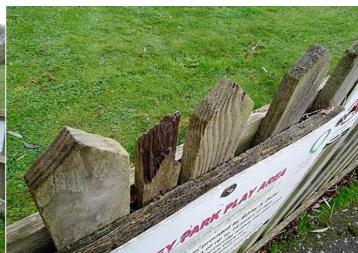
Item: Fences - Fencing - Timber

There are areas or parts of the timber on the structure that have rotted - Replace all affected timbers

Finding: There are areas or parts of the timber on the structure that have rotted

Action: Replace all affected timbers
