## Annual Inspection

Barby & Onley Parish Council

Barby Skate Ramp

Longdown Lane, Barby, CV23 8TE

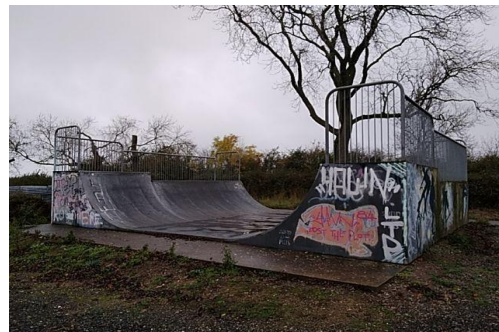
**Item:** Half Pipe  
**Manufacturer:** Unknown  
**Surface Type:** Concrete  
**Item Quantity:** 1  
**Equipment Compliance:** N/A  
**Surface Area Compliance:** N/A

There is some graffiti present - Remove the graffiti

There is some damage to the barrier sections - Monitor for any further deterioration and repair as required

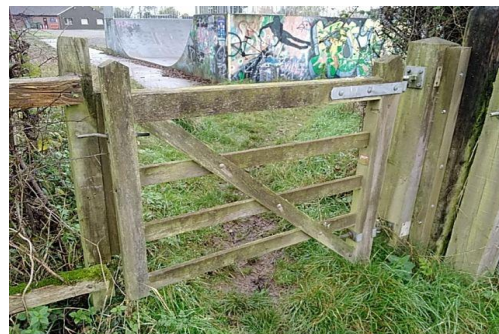
**Item:** Gate - Pedestrian  
**Manufacturer:** Unknown  
**Surface Type:** Grass  
**Item Quantity:** 1  
**Equipment Compliance:** N/A  
**Surface Area Compliance:** N/A

The item has missing latch component(s) - Recommend replacing missing components

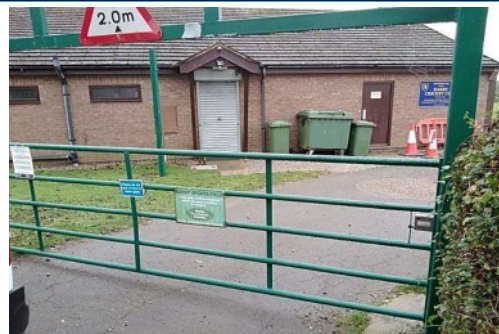
**Item:** Gate - Maintenance  
**Manufacturer:** Steelway/Fensecure  
**Surface Type:** Tarmac  
**Item Quantity:** 1  
**Equipment Compliance:** N/A  
**Surface Area Compliance:** N/A

This item is satisfactory - no work required -

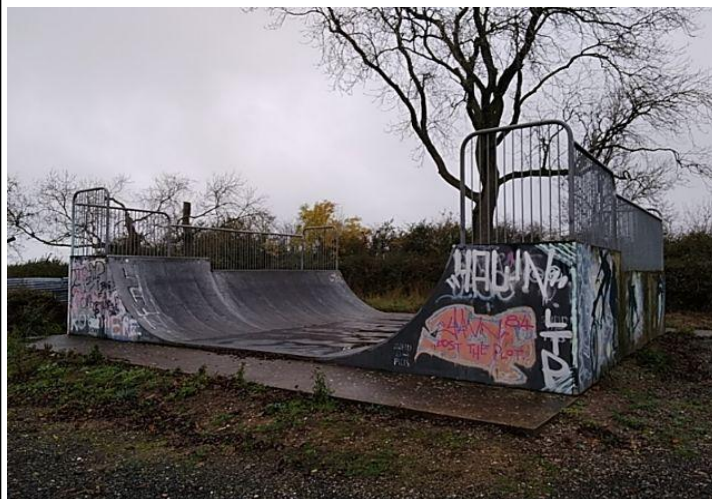
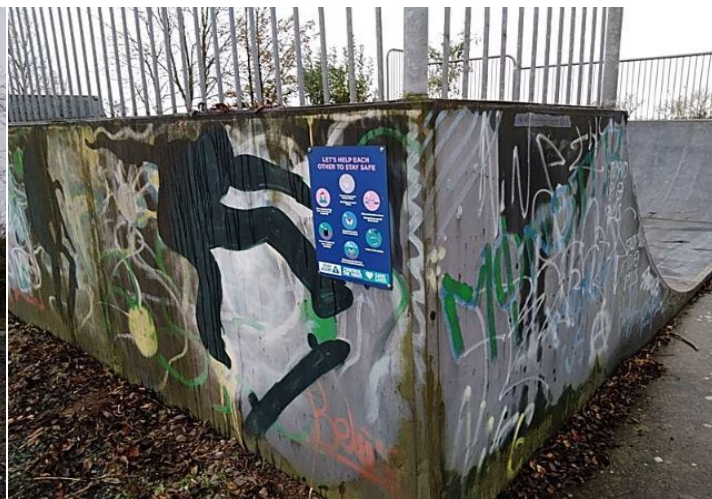
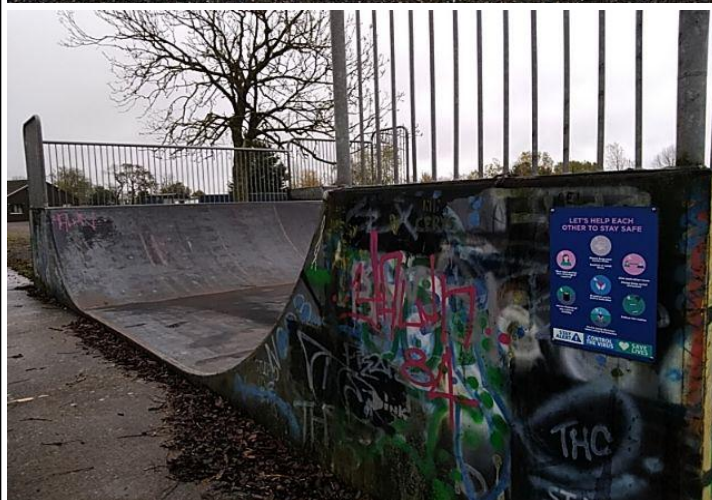
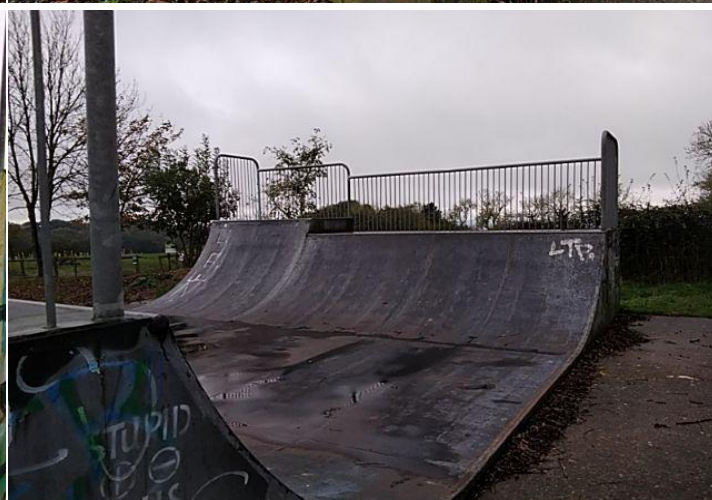
### 12 - Moderate Risk (Finding 1)

**Item:** Wheeled Sports - Half Pipe  
**Manufacturer:** Unknown

**Finding:** Signage of the wheeled sports area should be provided as recommended in BS EN 14974; this will include, a) facility for users of skateboards, inline-skates and BMX bikes (with site name or information); b) administrators identification with telephone number of the maintenance personnel and general emergency number; c) the facility is not a playground, its use is for adults, teenagers and children above the age of 8; d) the use of unsuitable equipment such as traditional road bikes, motorised sports equipment or toys is not permitted; e) use of appropriate protective equipment (e.g. helmet, knee pads, elbow pads, etc.) is recommended; f) pay attention to other users; g) the rolling surfaces and skate elements are not a waiting area and shall be kept clear of objects; h) the facility shall not be used when wet, icy or in snow conditions.

**Action:** Provide signage as recommended by BS EN 14974 for wheeled sports areas

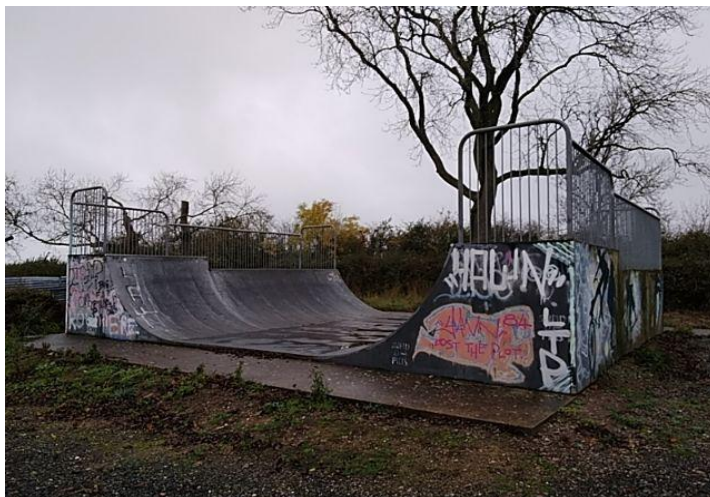
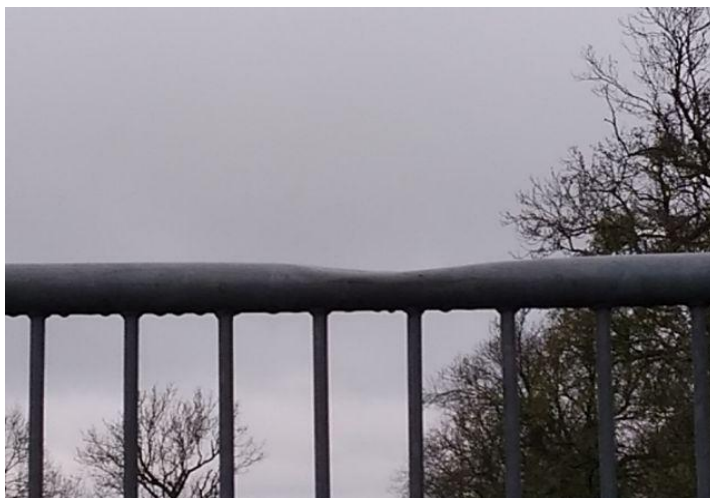
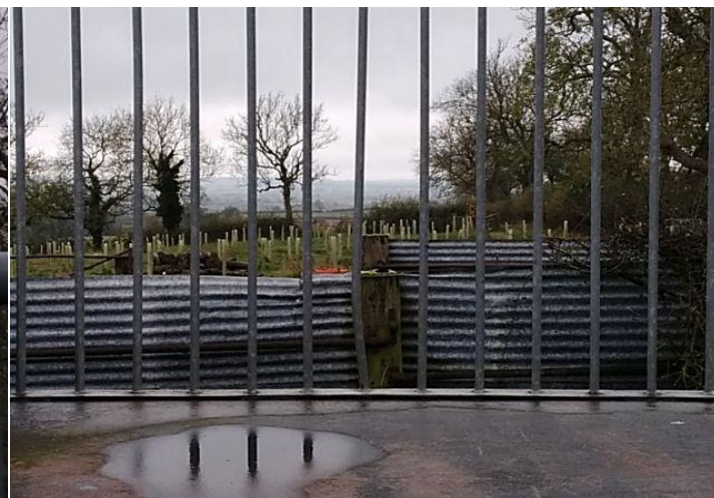
**i** 6 - Low Risk (Finding 2)

**Item:** Wheeled Sports - Half Pipe  
**Manufacturer:** Unknown

**Finding:** There is some damage to the barrier sections

**Action:** Monitor for any further deterioration and repair as required

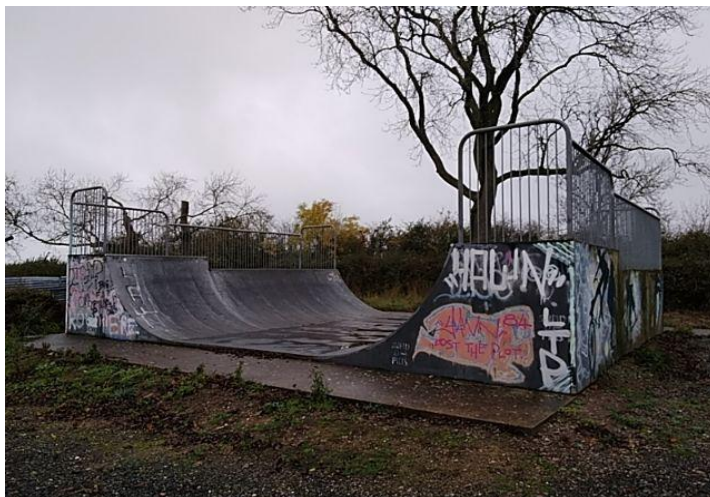
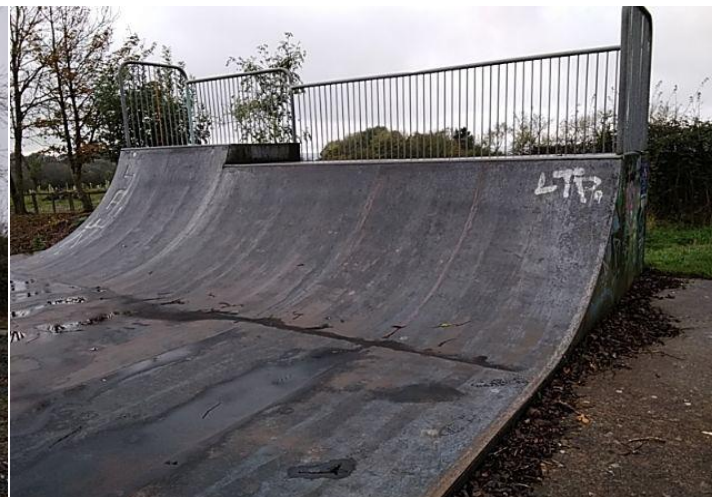
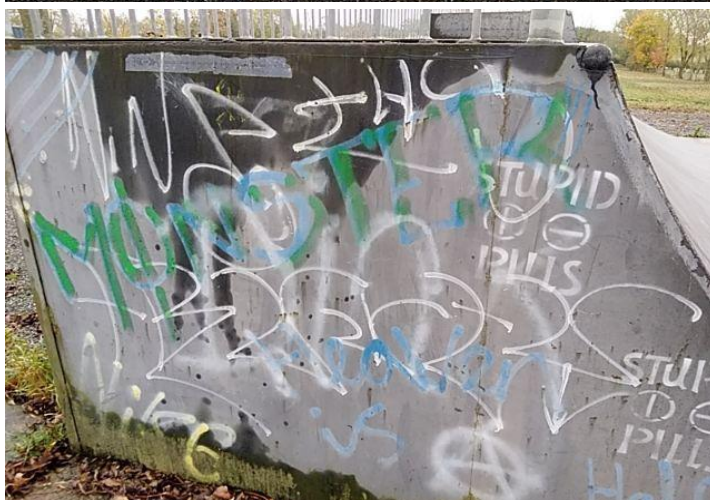
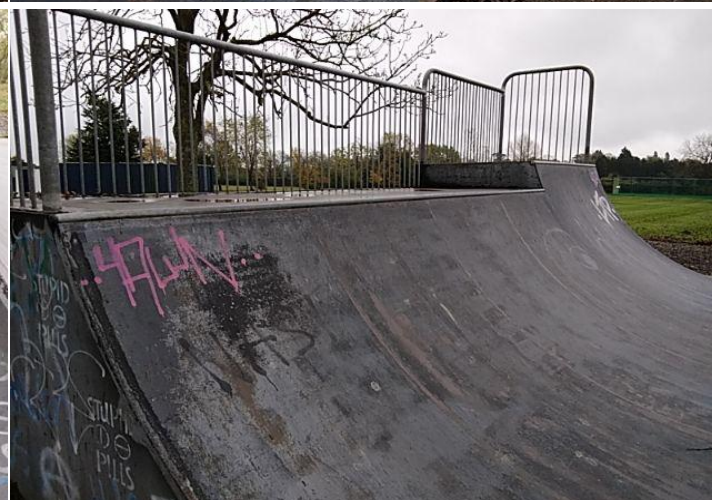
**i** 1 - Very Low Risk (Finding 3)

**Item:** Wheeled Sports - Half Pipe  
**Manufacturer:** Unknown

**Finding:** There is some graffiti present

**Action:** Remove the graffiti

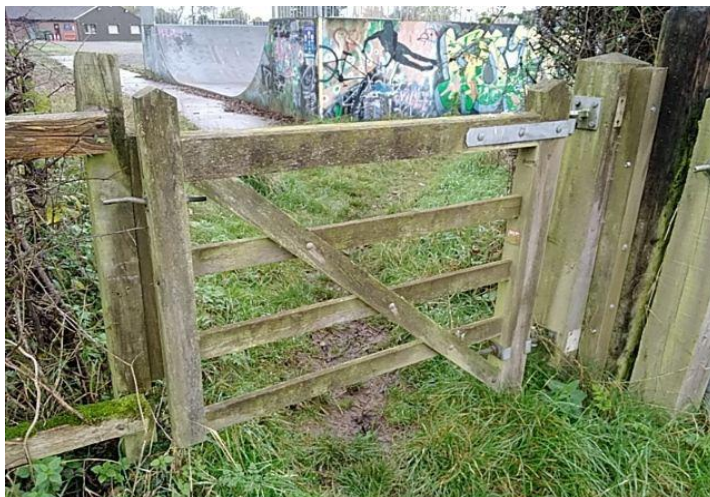
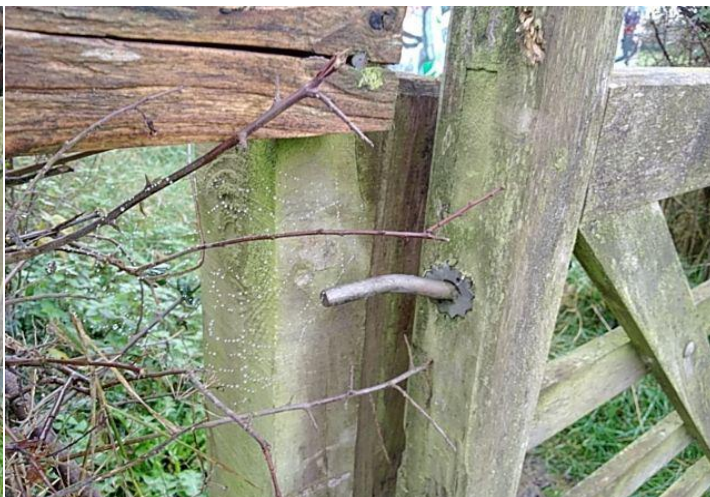
**i** 6 - Low Risk (Finding 1)

**Item:** Gates - Gate - Pedestrian  
**Manufacturer:** Unknown

**Finding:** The item has missing latch component(s)

**Action:** Recommend replacing missing components
