Annual Inspection

Barby & Onley Parish Council

Barby Play Area

Daventry Road, Barby, CV23 8TT

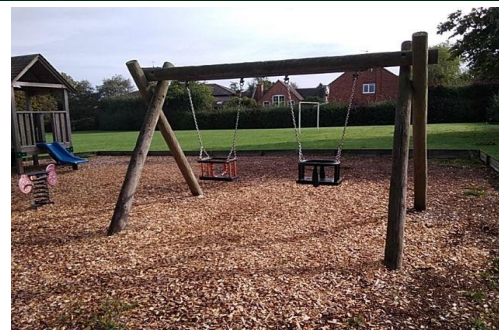
Item: 1 Bay 2 Seat (Cradle)
Manufacturer: Unknown
Surface Type: Bark Mulch
Item Quantity: 1
Equipment Compliance: N/A
Surface Area Compliance: N/A

The bushes are worn or missing - Replace worn or missing bushes

2 shackle nuts are missing - Replace all missing fixings

The timber has a number of splits/shakes or air cracks and this may affect the stability or allow water ingress which will accelerate the rotting process. The swing frame is in generally poor condition - Monitor to ensure the splits do not cross through fixing points of the structure and/or cause any instability. Consider replacing the swing frame in the longer term

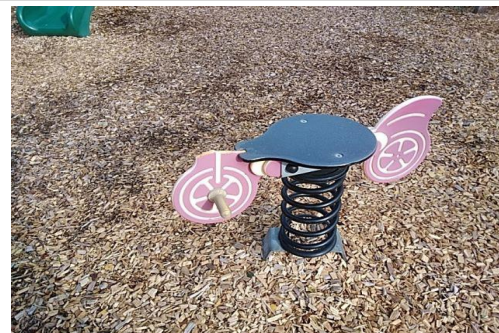
Item: Spring Bike
Manufacturer: Wicksteed Playgrounds
Surface Type: Bark Mulch
Item Quantity: 1
Equipment Compliance: N/A
Surface Area Compliance: N/A

The front section is broken. There is nothing for children to hold onto when using the item - Replace the damaged parts

The end of handgrips and/or footrests have a cross section of less than 15cm² and fail to meet the requirements of BS EN 1176 Part 6 - Monitor - No remedial work recommended

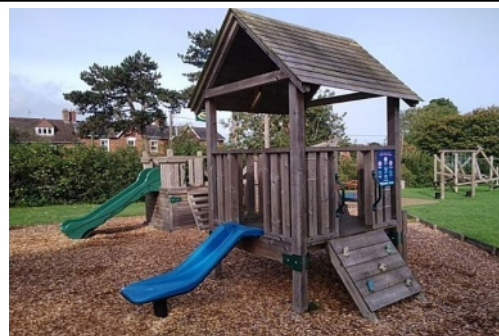
Item: Multi Play (Toddler)
Manufacturer: Sovereign Leisure
Surface Type: Bark Mulch
Item Quantity: 1
Equipment Compliance: N/A
Surface Area Compliance: N/A

This item is satisfactory - no work required -

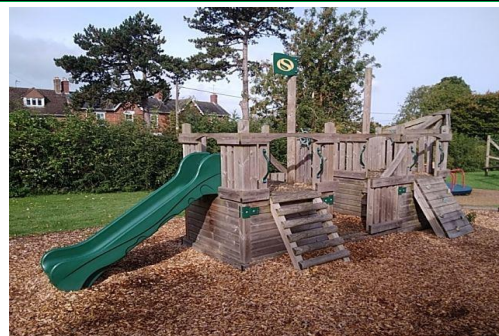
Item: Ship
Manufacturer: Sovereign Leisure
Surface Type: Bark Mulch
Item Quantity: 1
Equipment Compliance: N/A
Surface Area Compliance: N/A

There is some evidence of rot in the timber - Monitor for any further deterioration and replace as required

Some timber edging is missing - Monitor

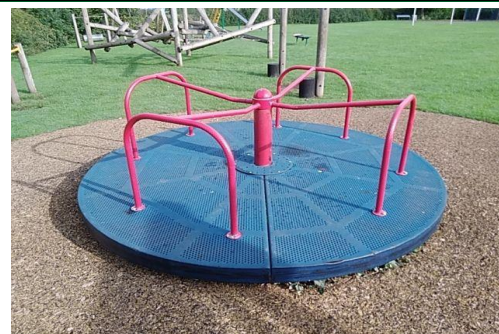
Item: Roundabout
Manufacturer: Unknown
Surface Type: EcoScape Softbond
Item Quantity: 1
Equipment Compliance: N/A
Surface Area Compliance: N/A

There are weeds/vegetation growth below the item -
Remove weeds/vegetation growth

The item is slightly loose in its foundations or the bearings
may be worn - Monitor for any further deterioration and
repair as required

The item has been damaged - Monitor for any further
deterioration and replace as required

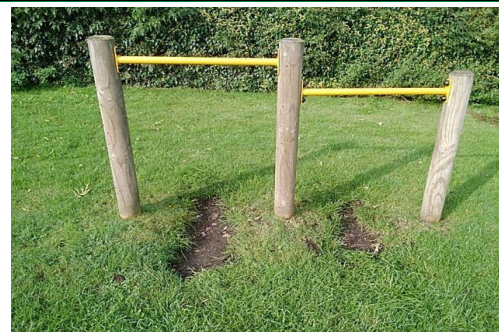
Item: Pull Up Station
Manufacturer: Unknown
Surface Type: Grass
Item Quantity: 1
Equipment Compliance: N/A
Surface Area Compliance: N/A

The surface has eroded in some areas - Reinststate the
surface

The timber has a number of splits/shakes or air cracks and
this may affect the stability or allow water ingress which will
accelerate the rotting process - Monitor to ensure the splits
do not cross through fixing points of the structure and/or
cause any instability

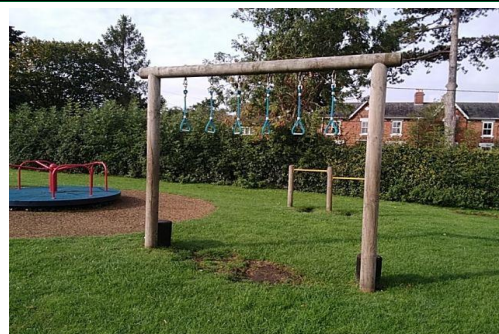
Item: Trapeze Rings
Manufacturer: Unknown
Surface Type: Grass Matrix Tiles
Item Quantity: 1
Equipment Compliance: N/A
Surface Area Compliance: N/A

The item is slightly loose in its foundations - Monitor for any further deterioration and repair as required

The timber has a number of splits/shakes or air cracks and this may affect the stability or allow water ingress which will accelerate the rotting process - Monitor to ensure the splits do not cross through fixing points of the structure and/or cause any instability

1 grass mat is missing - Replace the missing grass mat

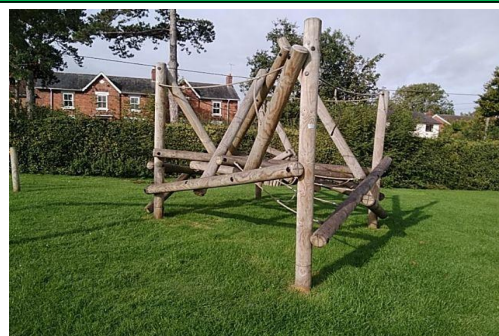
Item: Log Climber
Manufacturer: Unknown
Surface Type: Grass
Item Quantity: 1
Equipment Compliance: N/A
Surface Area Compliance: N/A

The timber has a number of splits/shakes or air cracks and this may affect the stability or allow water ingress which will accelerate the rotting process - Monitor to ensure the splits do not cross through fixing points of the structure and/or cause any instability

There is some strimmer / machinery damage apparent on the posts, this can penetrate the preservative applied to the timber and accelerate the rotting process - Monitor for any deterioration (rot) and replace as required

There is/are bolt cap covers missing or damaged on the item - Replace missing or damaged bolt cap covers

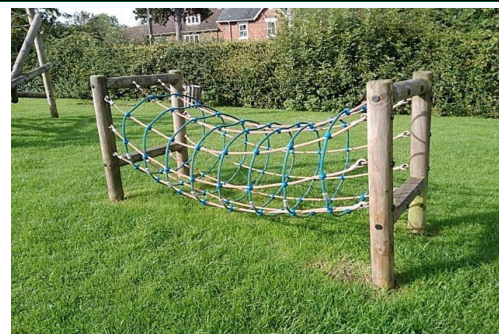
Item: Bridge
Manufacturer: Unknown
Surface Type: Grass
Item Quantity: 1
Equipment Compliance: N/A
Surface Area Compliance: N/A

There is/are bolt cap covers missing or damaged on the item - Replace missing or damaged bolt cap covers

The timber has a number of splits/shakes or air cracks and this may affect the stability or allow water ingress which will accelerate the rotting process - Monitor to ensure the splits do not cross through fixing points of the structure and/or cause any instability

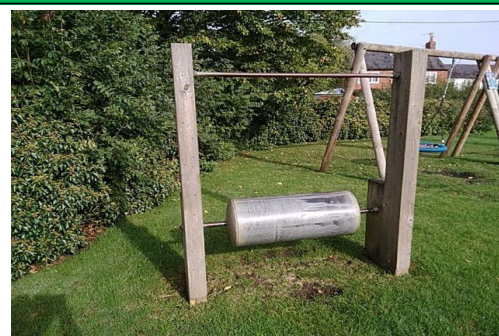
Item: Misc Item
Manufacturer: Unknown
Surface Type: Grass
Item Quantity: 1
Equipment Compliance: N/A
Surface Area Compliance: N/A

There is some evidence of rot in the timber - Monitor for any further deterioration and replace as required

There is some strimmer / machinery damage apparent on the posts, this can penetrate the preservative applied to the timber and accelerate the rotting process - Monitor for any deterioration (rot) and replace as required

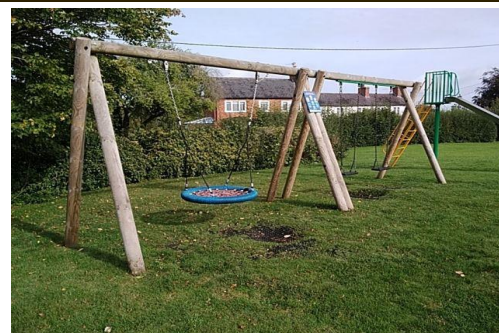
Item: 2 Bay 2 Flat 1 Basket Seat
Manufacturer: Unknown
Surface Type: Grass Matrix Tiles
Item Quantity: 1
Equipment Compliance: N/A
Surface Area Compliance: N/A

The edges of the grass mat surface have not been installed in accordance with the API Code of Practice - Tuck in edges of grass mat to remove trip hazards

The timber has a number of splits/shakes or air cracks and this may affect the stability or allow water ingress which will accelerate the rotting process - Monitor to ensure the splits do not cross through fixing points of the structure and/or cause any instability

Large dips in the playing surface - Repair the surface

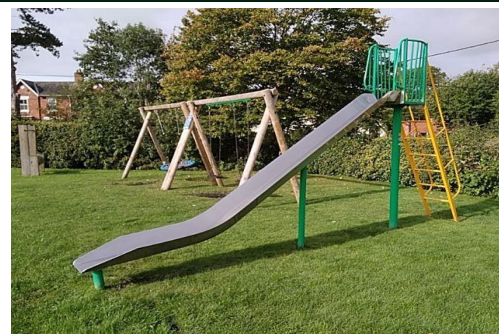
Item: Free Standing Slide
Manufacturer: Play & Leisure Ltd
Surface Type: Grass Matrix Tiles
Item Quantity: 1
Equipment Compliance: N/A
Surface Area Compliance: N/A

The slide is predominately south facing and will catch the majority of the sun's heat during the day. Slide surfaces can become very warm during periods of sustained sunny weather - Monitor - No remedial work recommended

Hole in the playing surface - Repair the surface

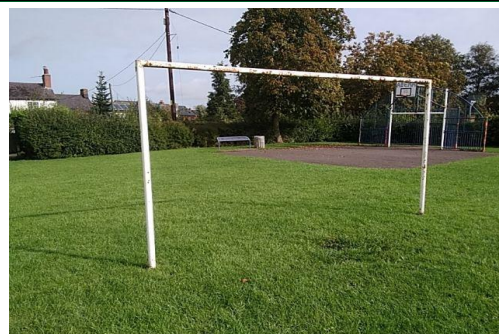
Item: Football Goal
Manufacturer: Unknown
Surface Type: Grass
Item Quantity: 2
Equipment Compliance: N/A
Surface Area Compliance: N/A

The surface has eroded in some areas - Reinstate the surface

There is surface corrosion present on the item - Consider treating the item

The item is slightly loose in its foundations - Monitor for any further deterioration and repair as required

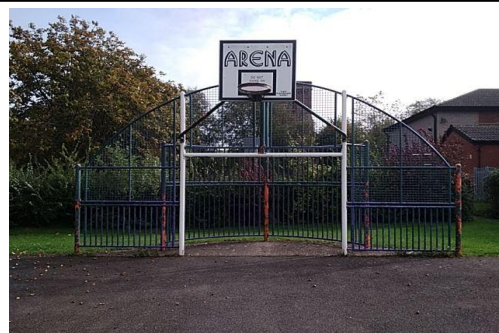
Item: Goalmouth and Basketball Post
Manufacturer: SMP
Surface Type: Tarmac
Item Quantity: 1
Equipment Compliance: N/A
Surface Area Compliance: N/A

The item has been damaged - Monitor for any further deterioration and replace as required

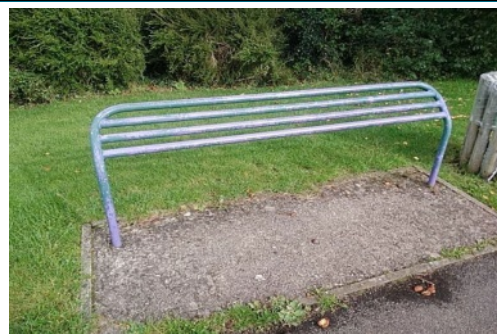
Item: Seat
Manufacturer: Unknown
Surface Type: Concrete
Item Quantity: 1
Equipment Compliance: N/A
Surface Area Compliance: N/A

This item is satisfactory - no work required -

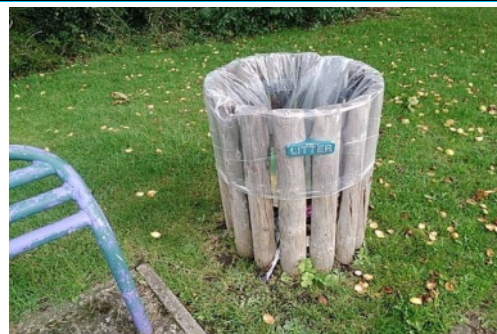
Item: Litter Bin
Manufacturer: Unknown
Surface Type: Grass
Item Quantity: 1
Equipment Compliance: N/A
Surface Area Compliance: N/A

This item is satisfactory - no work required -

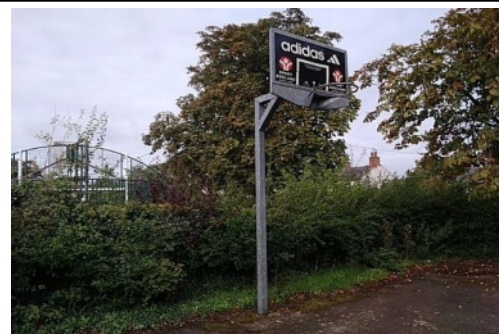
Item: Basketball Post
Manufacturer: Unknown
Surface Type: Tarmac
Item Quantity: 1
Equipment Compliance: N/A
Surface Area Compliance: N/A

This item is satisfactory - no work required -

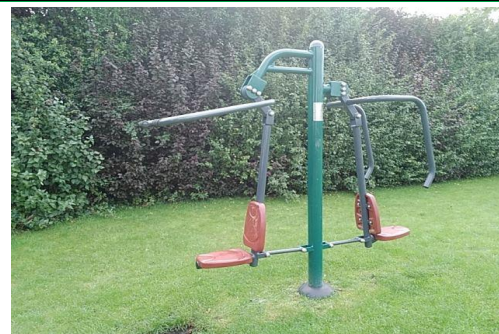
Item: Pull Down Challenger
Manufacturer: Sunshine Gym
Surface Type: Grass
Item Quantity: 1
Equipment Compliance: N/A
Surface Area Compliance: N/A

The surface has eroded in some areas - Reinstate the surface

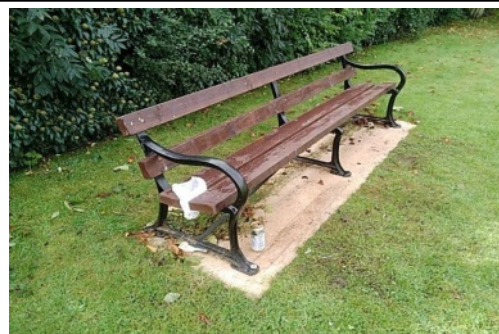
Item: Seat
Manufacturer: Unknown
Surface Type: Grass
Item Quantity: 2
Equipment Compliance: N/A
Surface Area Compliance: N/A

This item is satisfactory - no work required -

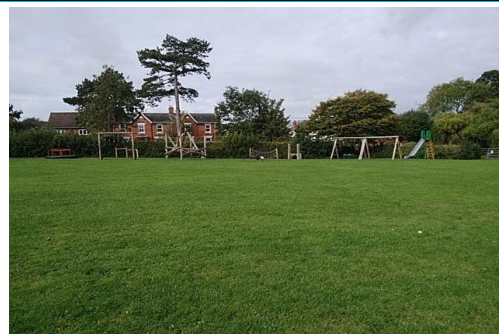
Item: Site General
Manufacturer: Unknown
Surface Type: Grass
Item Quantity: 1
Equipment Compliance: N/A
Surface Area Compliance: N/A

It is recommended that signage, with information including the site address, contact information for maintenance issues and emergency contact details are provided for the facility - Provide in accordance with the recommendations

Fungus was found on site - Remove as required

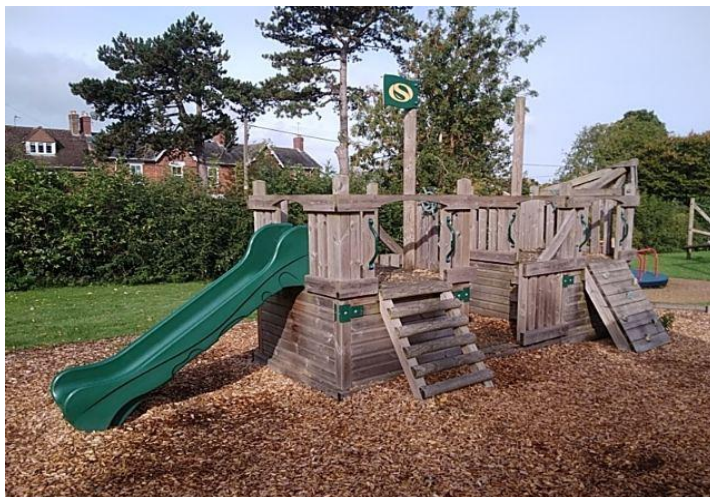
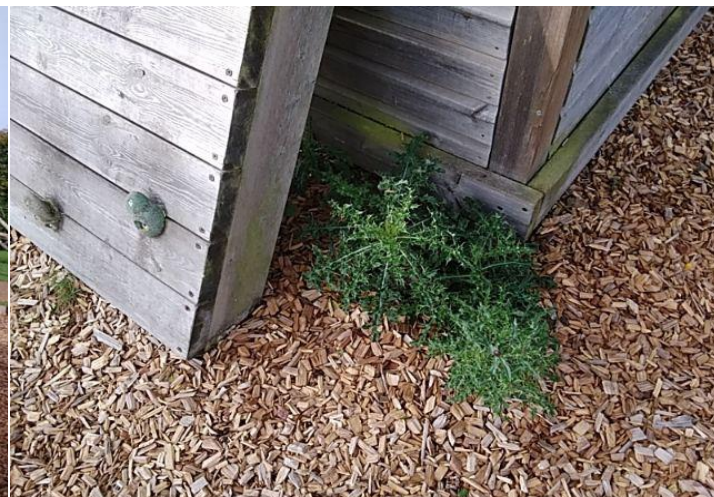
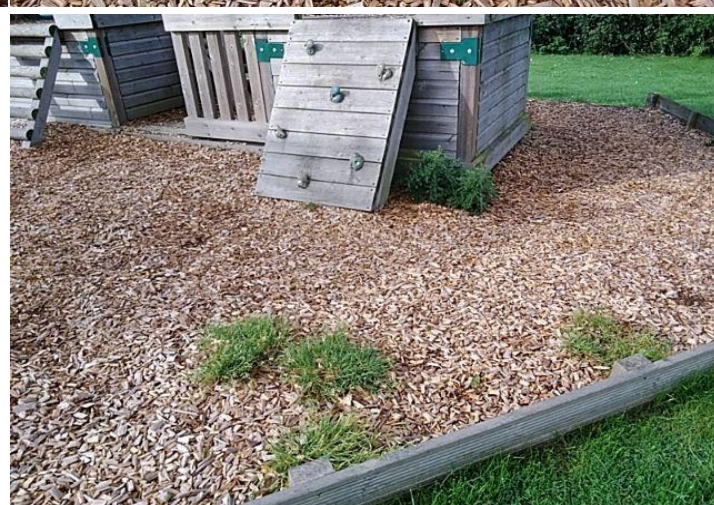
Item: Activity Equipment - Ship
Manufacturer: Sovereign Leisure

Finding: There are weeds/vegetation growth between or around the edges of the surfacing

i 6 - Low Risk (Finding 3)

Action: Remove weeds/vegetation growth

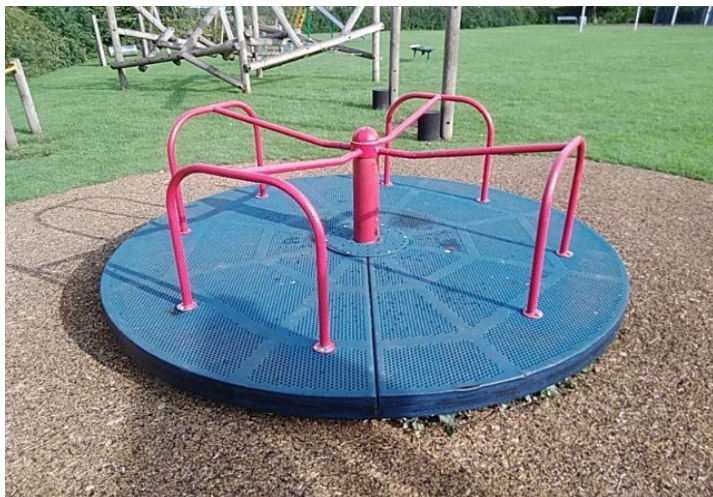
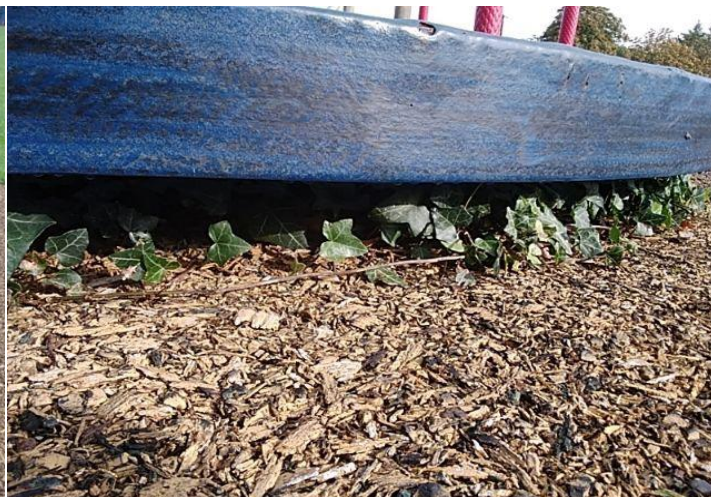
Item: Rotor Play - Roundabout
Manufacturer: Unknown

Finding: There are weeds/vegetation growth below the item **Action:** Remove weeds/vegetation growth

i 6 - Low Risk (Finding 2)

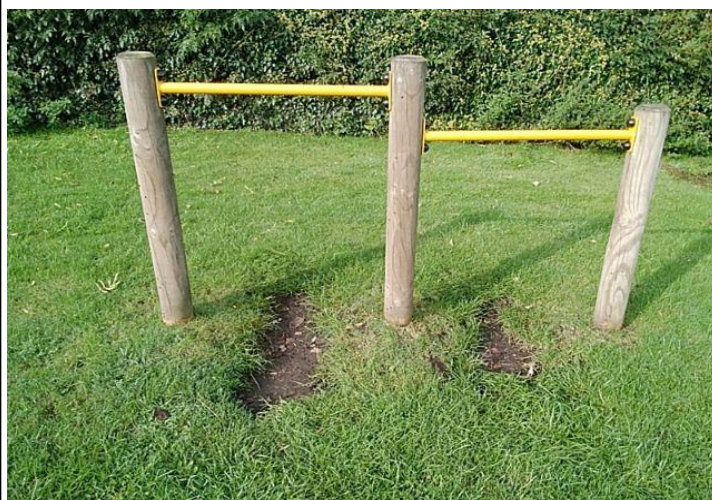
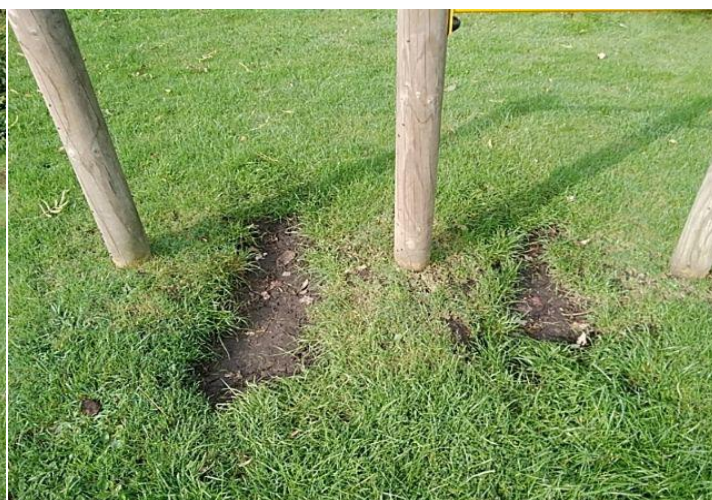
Item: Outdoor Fitness Equipment - Pull Up Station
Manufacturer: Unknown

Finding: The surface has eroded in some areas

Action: Reinststate the surface

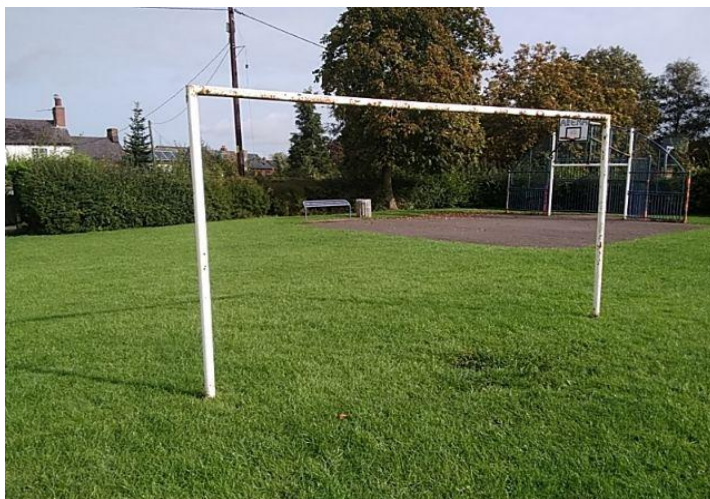
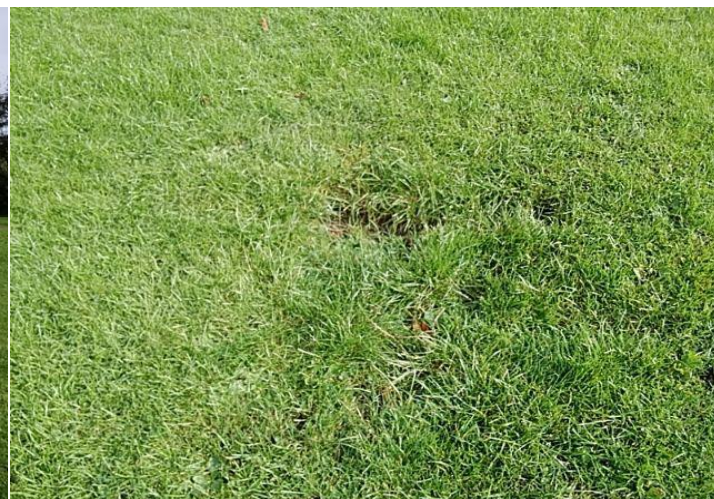
Item: Multi Use Games Area - Football Goal
Manufacturer: Unknown

Finding: The surface has eroded in some areas

Action: Reinstate the surface

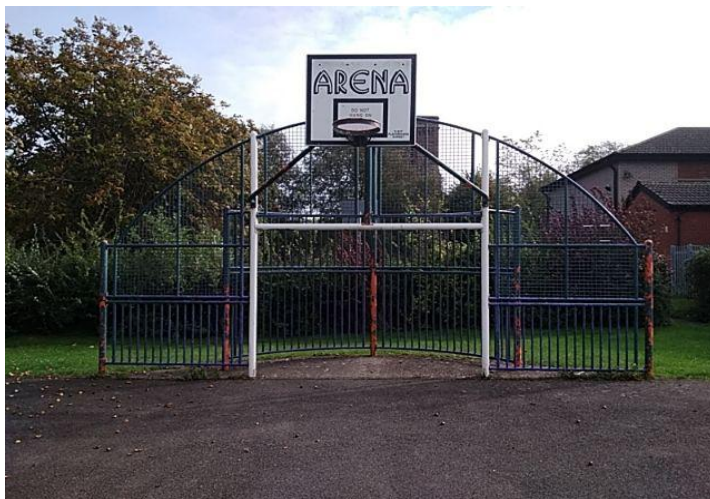
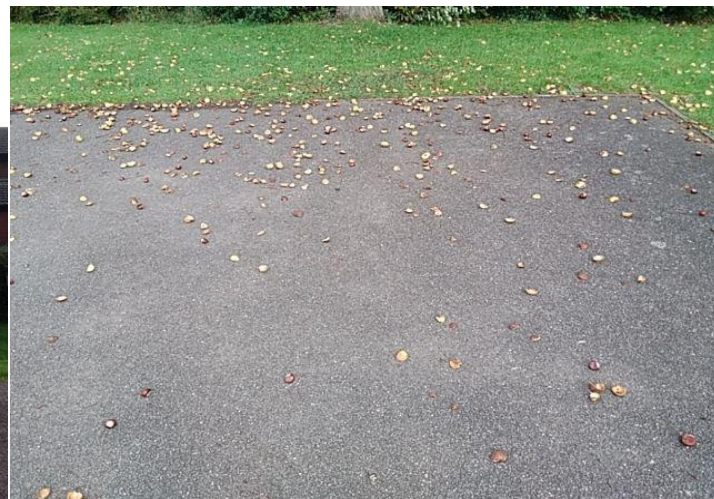
Finding: Large number of conkers on the playing surface

6 - Low Risk (Finding 1)

Action: Remove as required

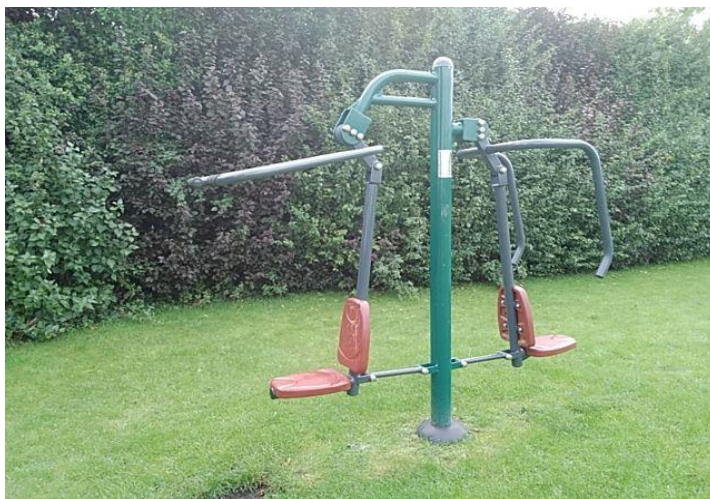
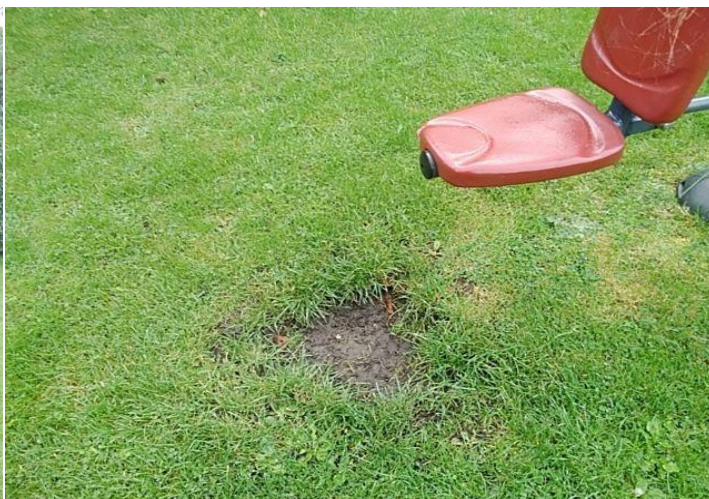
Finding: The surface has eroded in some areas

Action: Reinstate the surface
