Annual Inspection

Barby & Onley Parish Council

Onley Play Area

Inspection Ref: 2186532

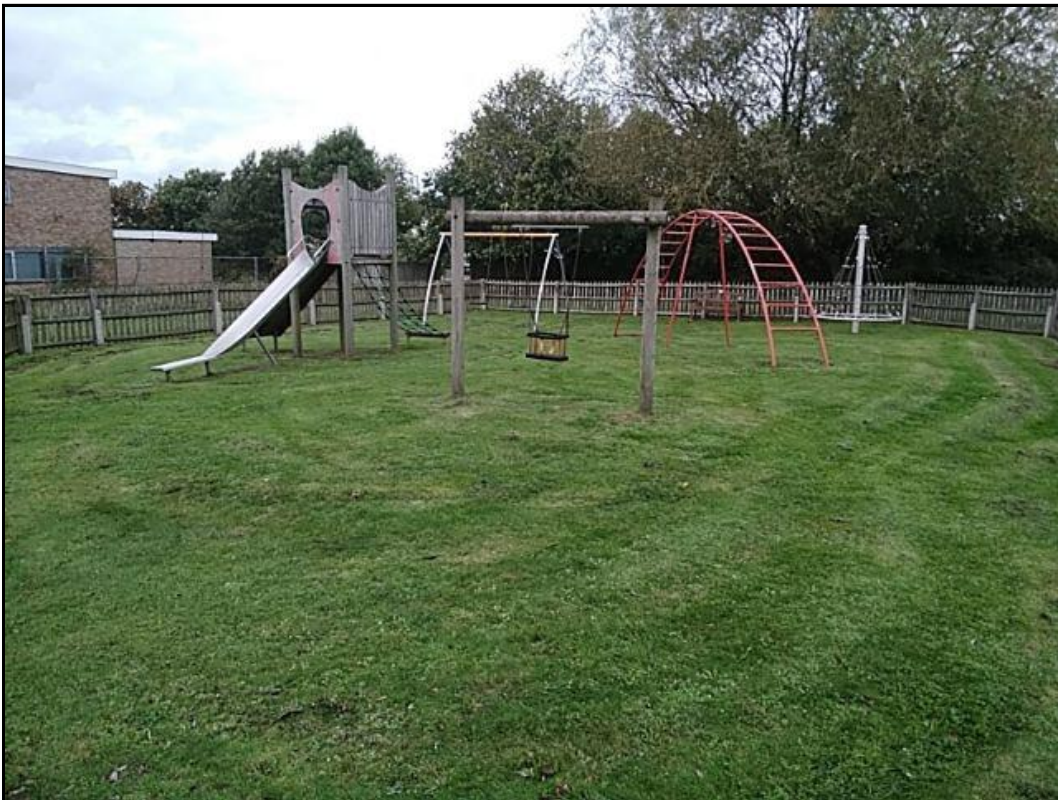
Location:

The site is located in an area of public open space and is overlooked by a number of properties in the local community.
