Annual Inspection

Barby & Onley Parish Council

Barby Village Hall Play Area

Inspected: 29-October-2024 - 08:39 by Michael Allbright

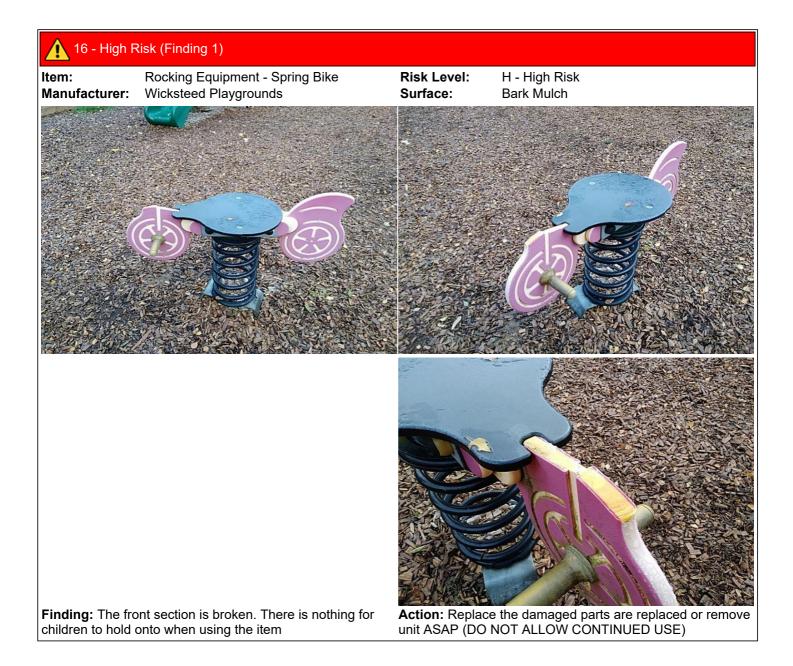
The front section is broken. There is nothing for children to The end of the footrests have a cross section of less than hold onto when using the item - Replace the damaged parts 15cm2 and fail to meet the requirements of BS EN 1176 are replaced or remove unit ASAP (DO NOT ALLOW CONTINUED USE)

6 - Low Risk (Finding 2) Item: Rocking Equipment - Spring Bike Manufacturer: Wicksteed Playgrounds Finding: The end of the footrests have a cross section of Risk Level: L - Low Risk Surface: Bark Mulch
