Annual Inspection

Barby & Onley Parish Council

Onley Play Area

Inspection Ref: 2522617 Site Ref: 90999
Property Ref:1267033-425810 Service Object Ref:

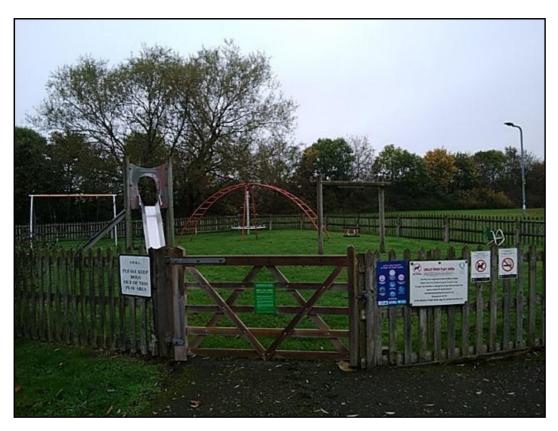
Risk Assessment: 12 Moderate Risk
